Engine Polygraph Case History: Mercedes 15

CS-EP-03

Mercedes I5

Vehicle ID : 2006 Dodge Sprinter

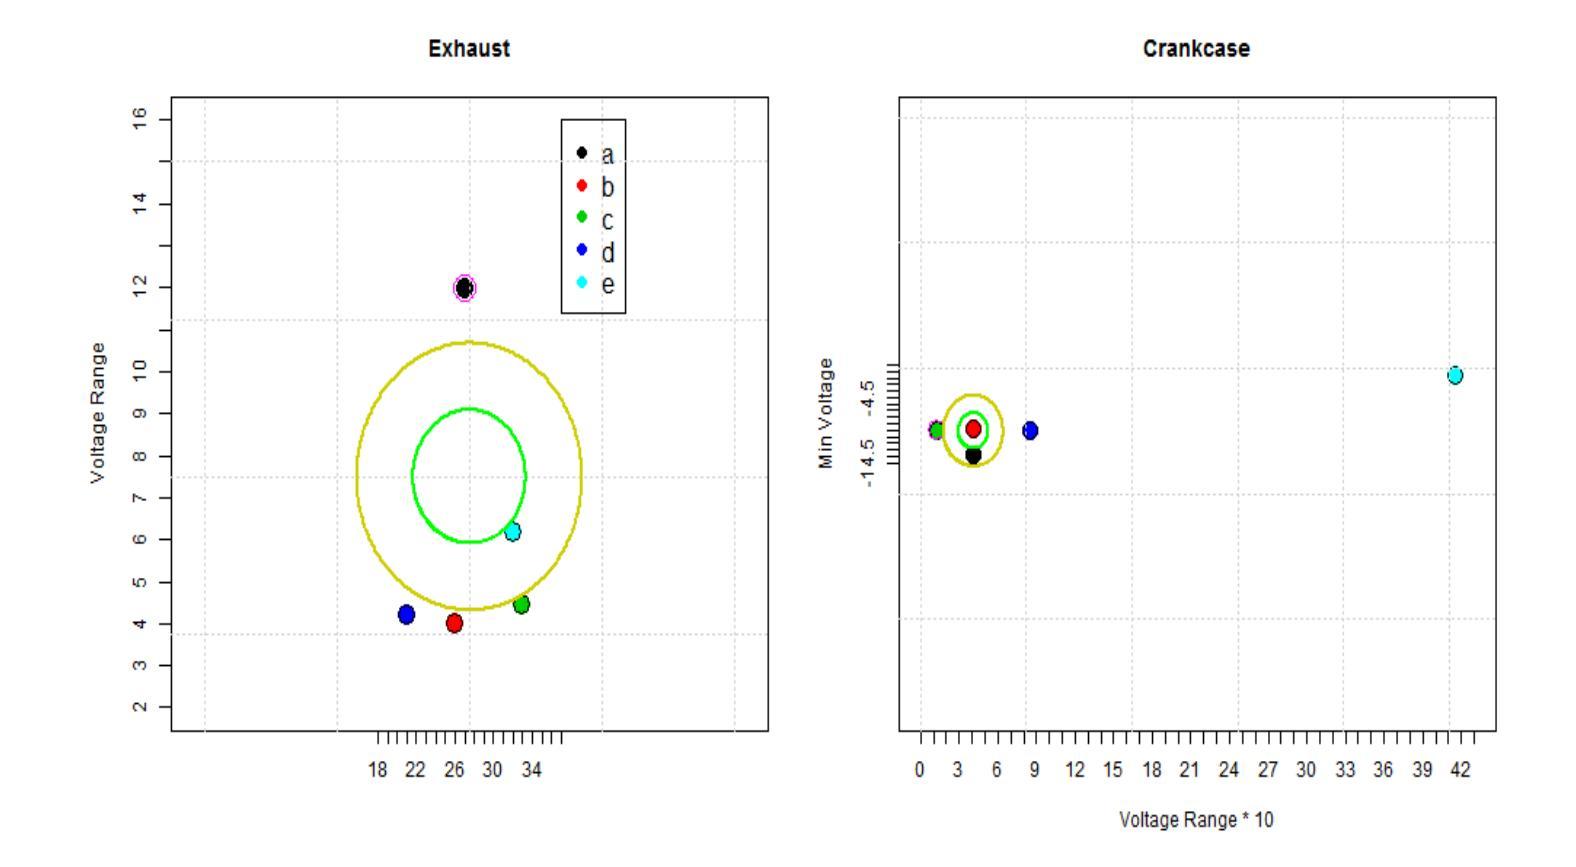
Cylinder Consistency Charts

Cylinder a has much more pressure range than any of the others; Cylinder e has extreme pressure range compared to the others.

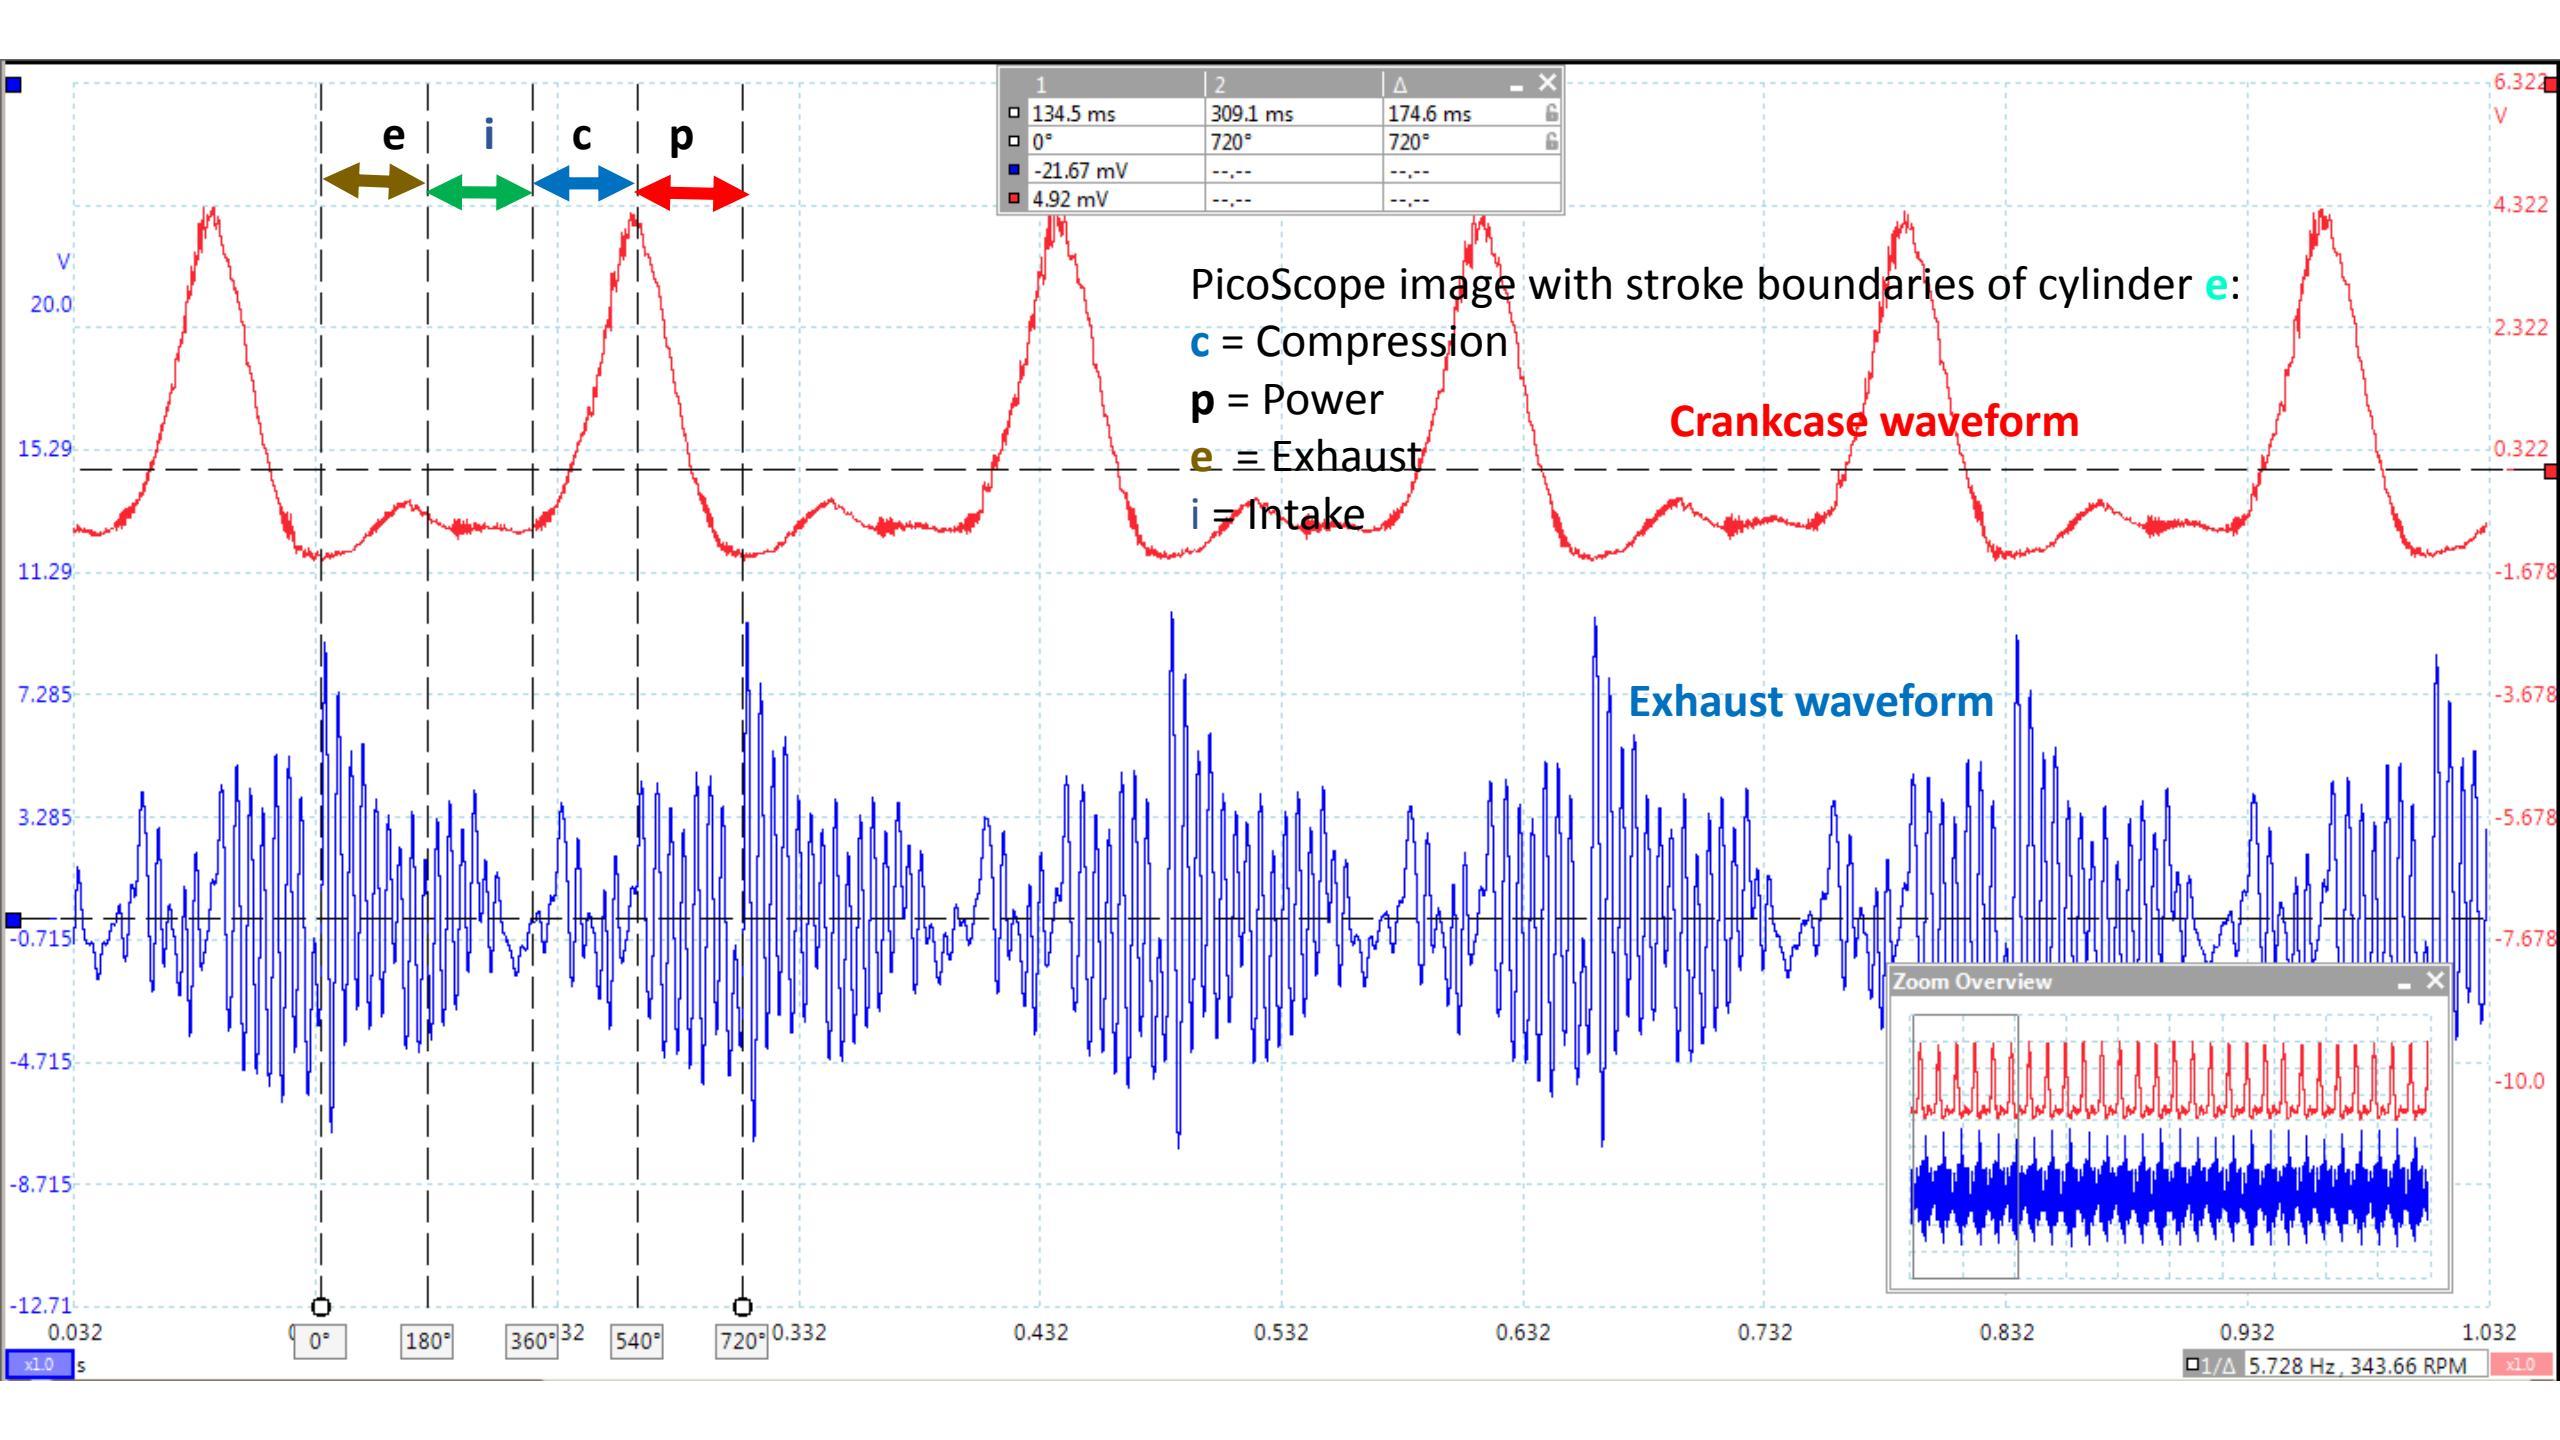
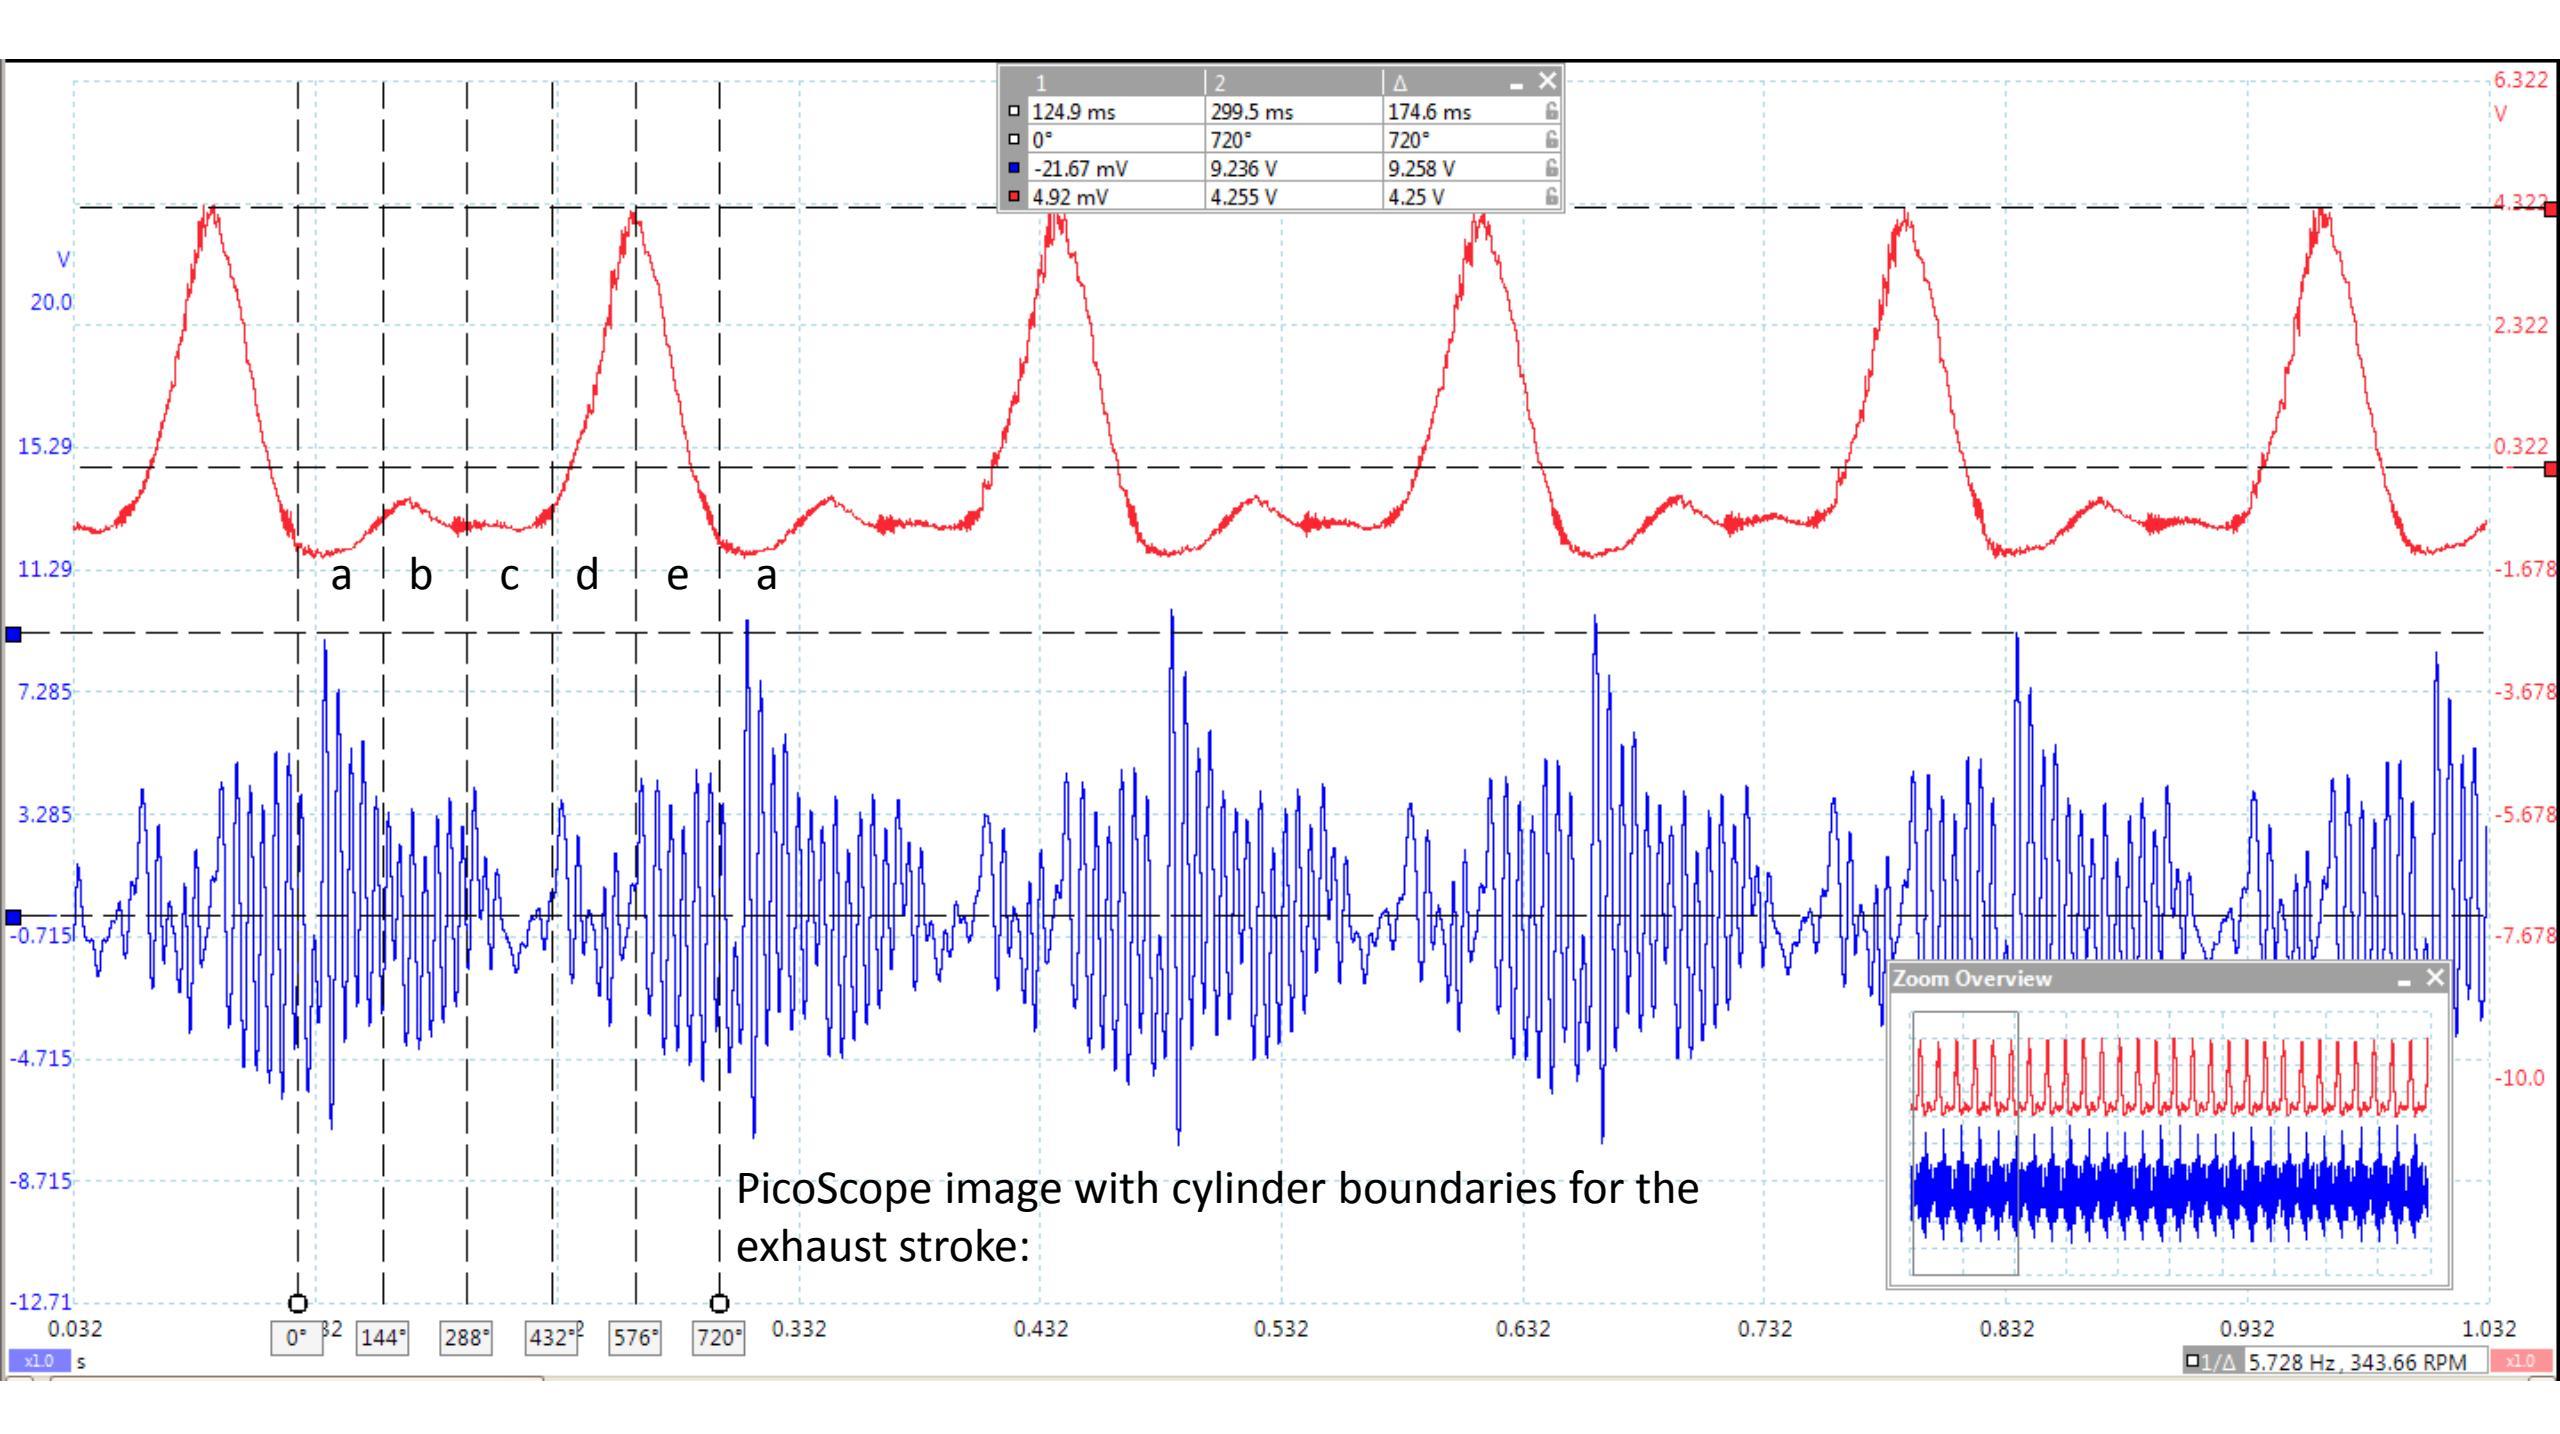
Waveform Analysis

The EP system did not get the rpm correct because a cylinder did not fire.

This pattern indicates that there is a regular mis-fire with fuel: the mis-fire is the Exhaust flat area at c. And it is followed by a large peak when the fuel that was not combusted hit the catalytic convertor and flashed.

The crankcase shows a huge pressure surge once per engine cycle (two rotations. This cylinder overshows all the other cylinders in the crankcase.

The mis-fire is due likely due to lack of compression in the compression stroke; the fuel was injected but no ignition. Therefore no exhaust to speak of.

On the Crankcase graph from d to e is the compression stroke and from e to a is the power stroke. Both intake and exhaust valves are closed so when the piston goes up, it blows pressure into the cc; in the power stroke, the pressure returns to normal.

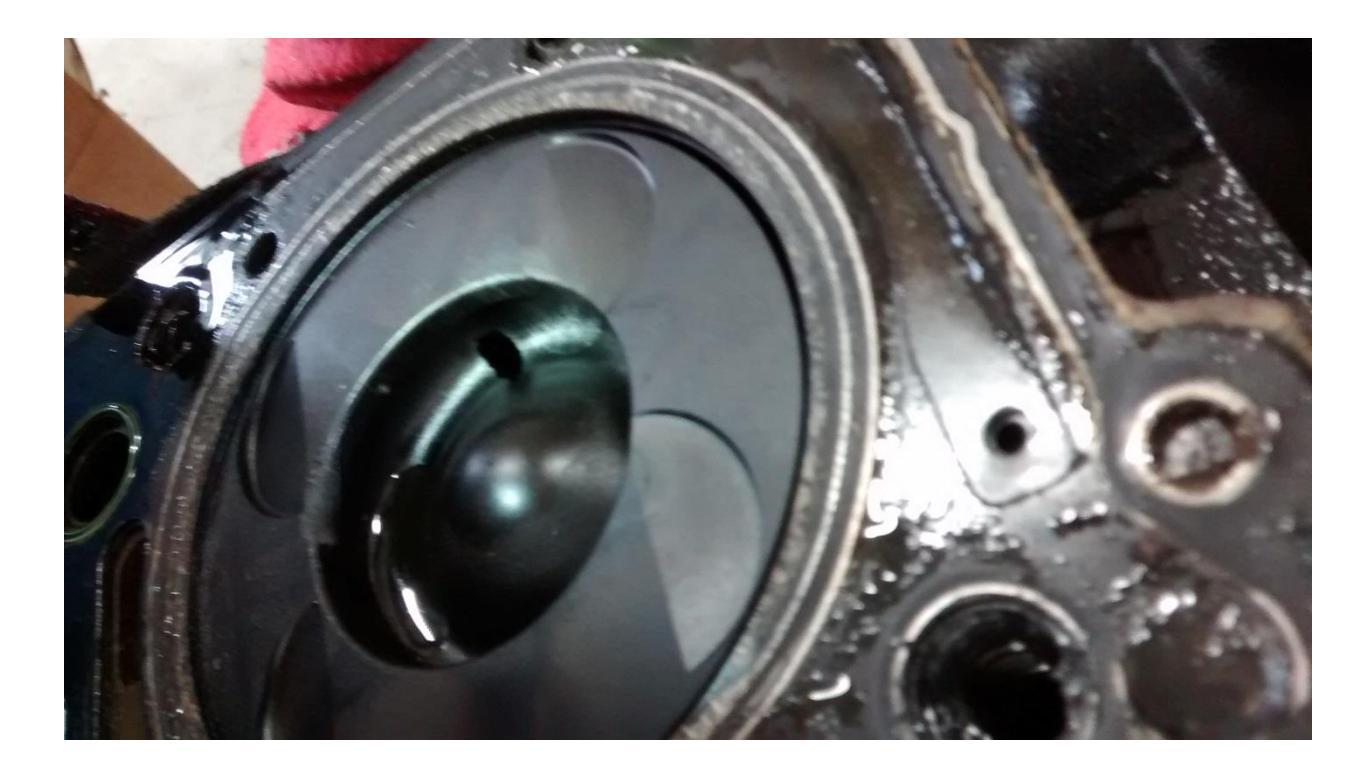
When they took the engine apart, they found the problem - a hole burnt through the piston. Probably as result in detonations from premature ignition (compression stroke) before the hole burned through.
