Direct Injection And Carbon Deposits

DIRECT INJECTION

FUEL-RELATED DTCs

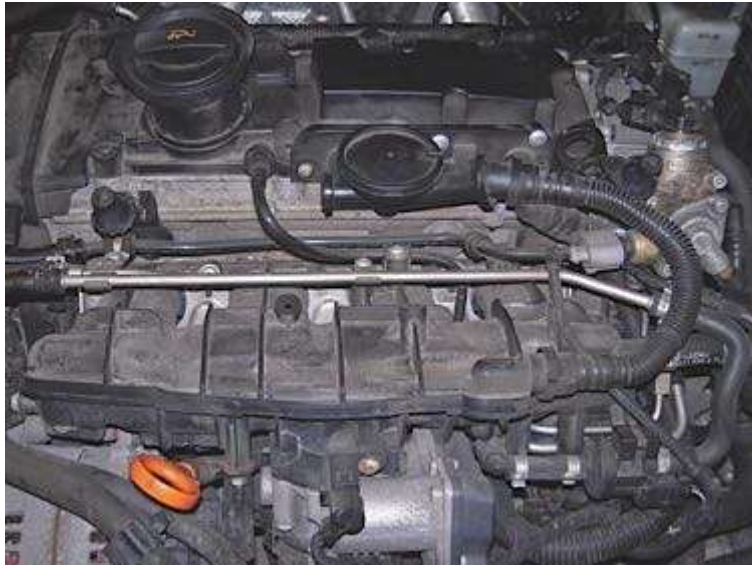
Photo 1

When the first Audis and Passats came out with direct injection in 2006, the hardening of the camshafts was insufficient and excessive wear could occur, causing the MIL to come on and DTC P2293 to be stored in the ECU. The code was for fuel pressure regulator 2 performance. Sometimes, DTCs P0087 (fuel pressure too low) and P1093 (fuel trim bank 1 malfunction) would also be stored.

The engines that were affected were the Audi 2.0L turbo (BPG) and the VW 2.0L turbo (BPY) (**see Photo 1**). The earliest TSB I found addressing the issue was from June 18, 2007. If you suspect the car you're working on has this issue, the high-pressure pump will need to be removed to determine the extent of the damage to the cam follower, the camshaft or even the pump itself. Remove the pump to inspect the follower only when the engine is cold and be sure to release the high pressure before disconnecting the lines.

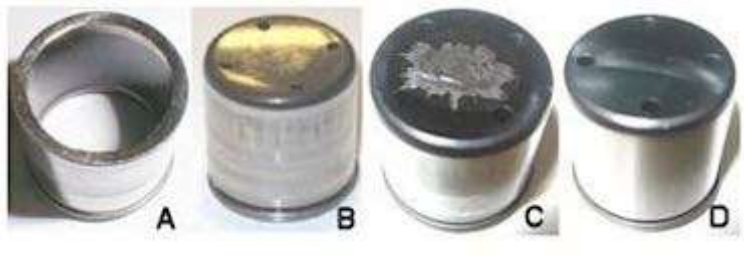
Figure 1

3. Carefully remove the pump. The cam follower may stay in the cylinder head. Take a look at the pump and follower and determine if there is abnormal wear that needs to be addressed (see Fig. 1). The pump can be reused unless the follower is completely worn through, which causes direct contact with the cam lobe (see Figures 2 and 3).

4. If the follower is excessively worn, carefully inspect the cam lobe to determine if the intake camshaft will need to be replaced. If the camshaft needs to be replaced, there is a new camshaft (P/N 06f109101b) that has increased hardening of the camshaft lobe.
