# Direct Injected Engines from Some Automakers are Seeing Reduced Performance

## Reduced performance is blamed on carbon deposits

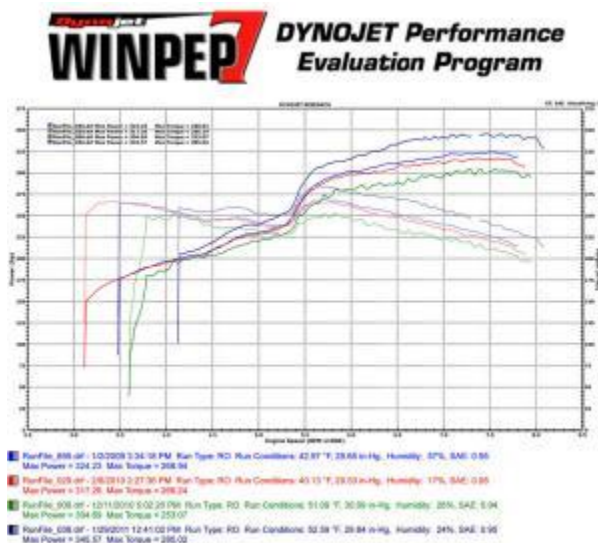
Dyno sheet for Constantine Boyadjiev's Audi RS 4 (Source: AutoObserver)

Boyadijev said, "The loss of performance became very noticeable over time." Boyadijev took his RS 4 to a dyno to help document the problem. He reports that when the RS 4 has 15,000 miles on the clock it produced 324 all-wheel horsepower. At 20,000 miles, the same dyno showed 317 AWHP, and at another 5,000 miles, the car produced 305 AWHP.

Boyadjiev said that he paid \$1,200 to have the engine cleaned of carbon deposits and when the car went back to the same dyno it put down an extra 41 AWHP. Different engine designs are also having less of an issue with carbon build up so some of the issue lies with the engineers that design the motors.
