Volumetric Efficiency Diagnostics

by [Glen Beanard](#) - Dec 29, 2014

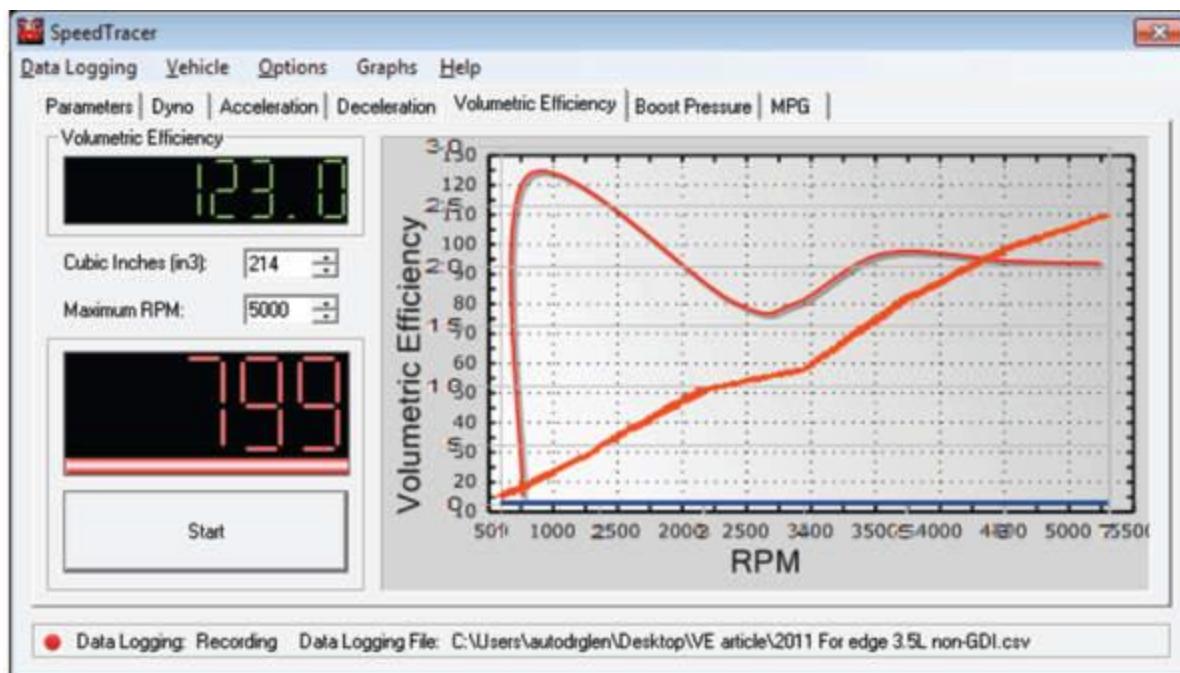
Fig. 1 shows a 2011 Ford Edge 3.5L and is a perfect example of a normal vehicle while set up in a proper starting position. The red tracer is the VE graphing generated by the tool, and the MAF sensor information (orange line) and the time line (blue line) were added after this event's recording for frame of reference.

Fig. 1 shows a 2011 Ford Edge 3.5L and is a perfect example of a normal vehicle while set up in a proper starting position. The red tracer is the VE graphing generated by the tool, and I added the MAF sensor information and time from this event's recording. The orange tracer represents the MAF reading, and the blue line is the time line.

The acceleration event in Fig. 1 lasted about 4.5 seconds.

Notice from idle to about 2,200 rpms that the airflow increases at a sharper rate. We have hit the MAF sensor with a sledgehammer of air. The software recognized the rate at which the air rushed in and depicted the throttle opening event as a sharp rise in VE. The peak reading is 123%.

The VE reacted in such an exaggerated way because the initial rush of air that filled the intake was much larger than what the engine should be flowing at idle rpms.

We know that air must pass the MAF before the engine can make use of it, so add that to any minor data refresh delays and we end up with an obvious spike in VE that depicts the event.

Due to the vehicle setup conditions, throttle snap-open becomes the highest VE capture. This is where we can derive the MAF sensor's state of health. The rest of the graph depicts how the engine mechanical is able to catch up to the high VE average at the beginning of the event rather than at the end.

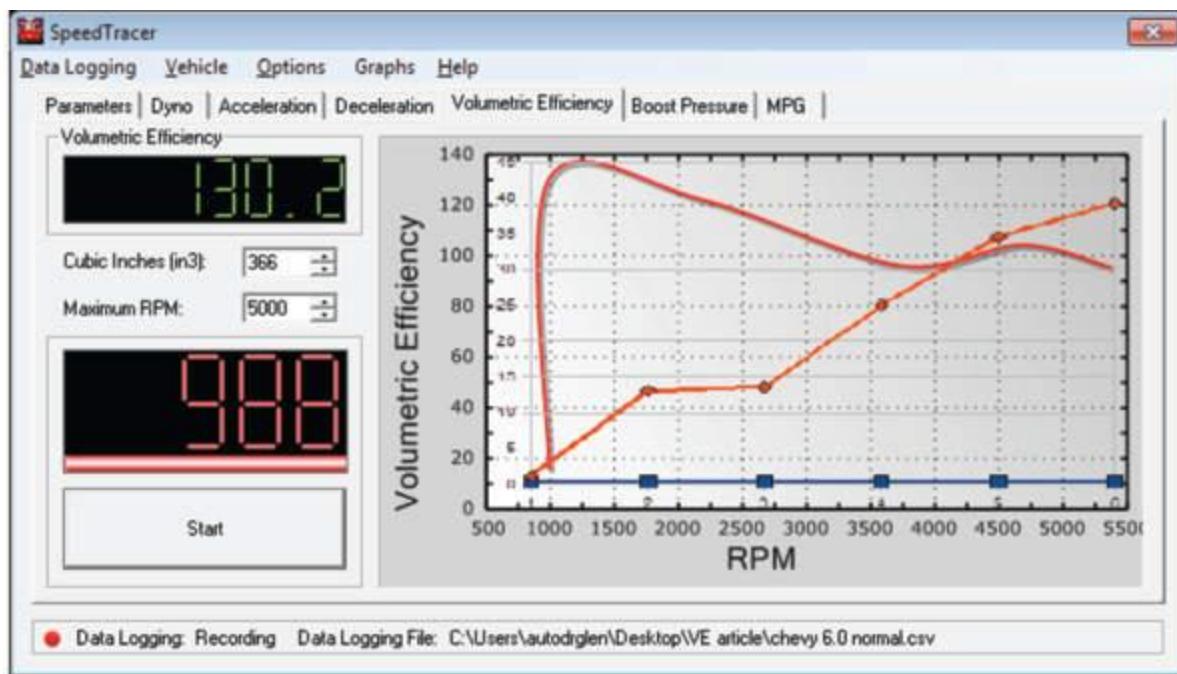
Figure 2 is a 2010 Chevy 6.0L truck.

Fig. 2 is a 2010 Chevy 6.0L truck. Fig. 3 is a 2004 Toyota Highlander 2.4L. By now, you should be able to look at these without the MAF tracer added, and we can still identify the events.

Notice how, even though these are completely different vehicles, we can repeat the pattern and put a number range on the MAF.

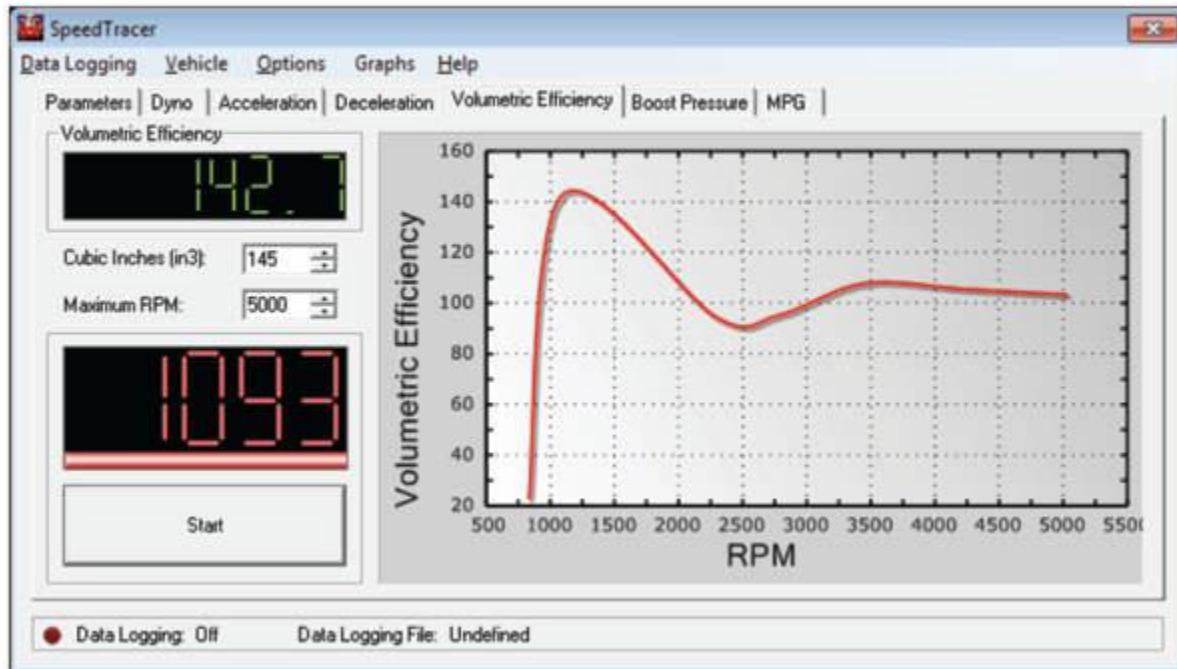
Figure 3 is a 2004 Toyota Highlander 2.4L

You can see the partial exhaust restriction in the 2.4L Toyota Highlander's capture in Fig. 8. This is the same vehicle as Fig. 3, but Fig. 3 (page 38) is post-repair.

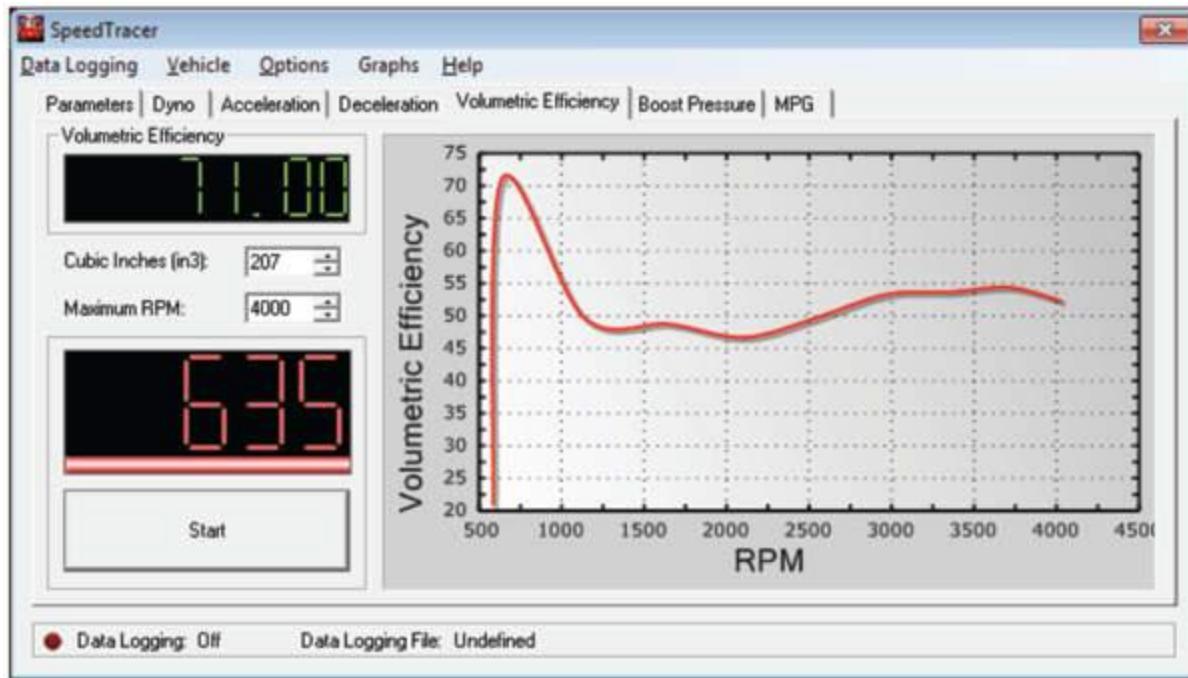
Fig. 4: 1999 Toyota 3.4L engine with an underreporting MAF.

The average length of time of these samples is roughly 4.5 seconds. Within that time, we can detect an underreporting MAF, like the 1999 Toyota 4Runner 3.4L in Fig. 4.

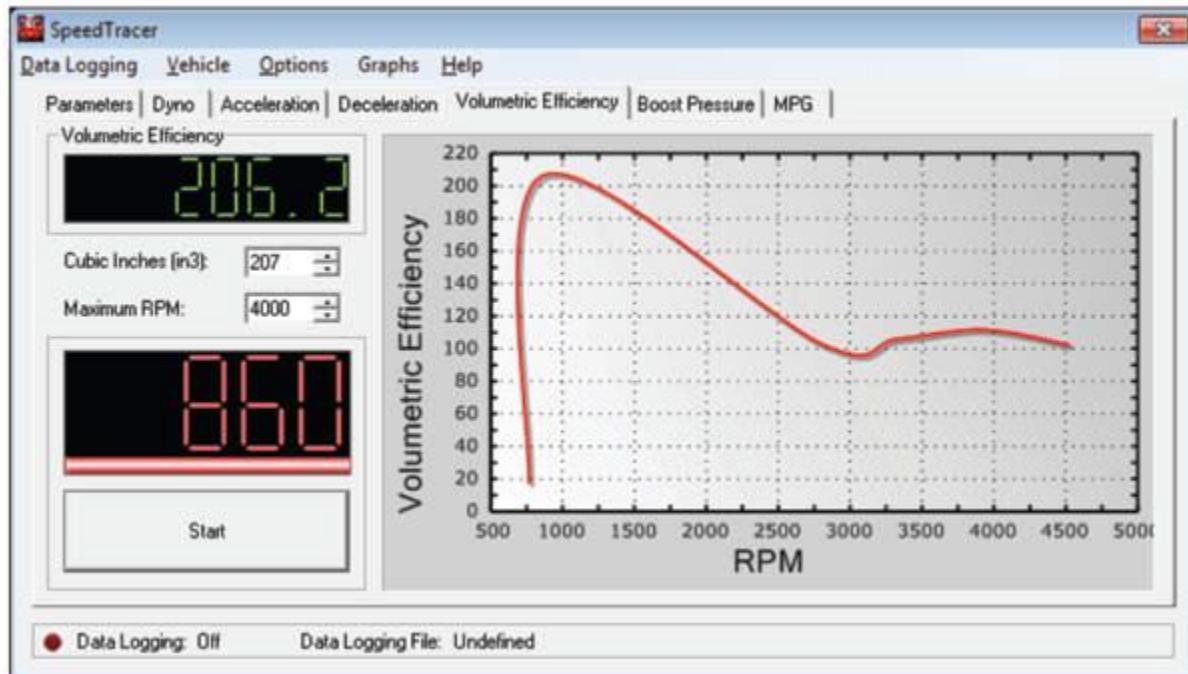
Fig. 5: 1999 Toyota 3.4L engine with a new MAF sensor installed.

See the difference of a new MAF sensor on the same 3.4L 4Runner in Fig. 5.

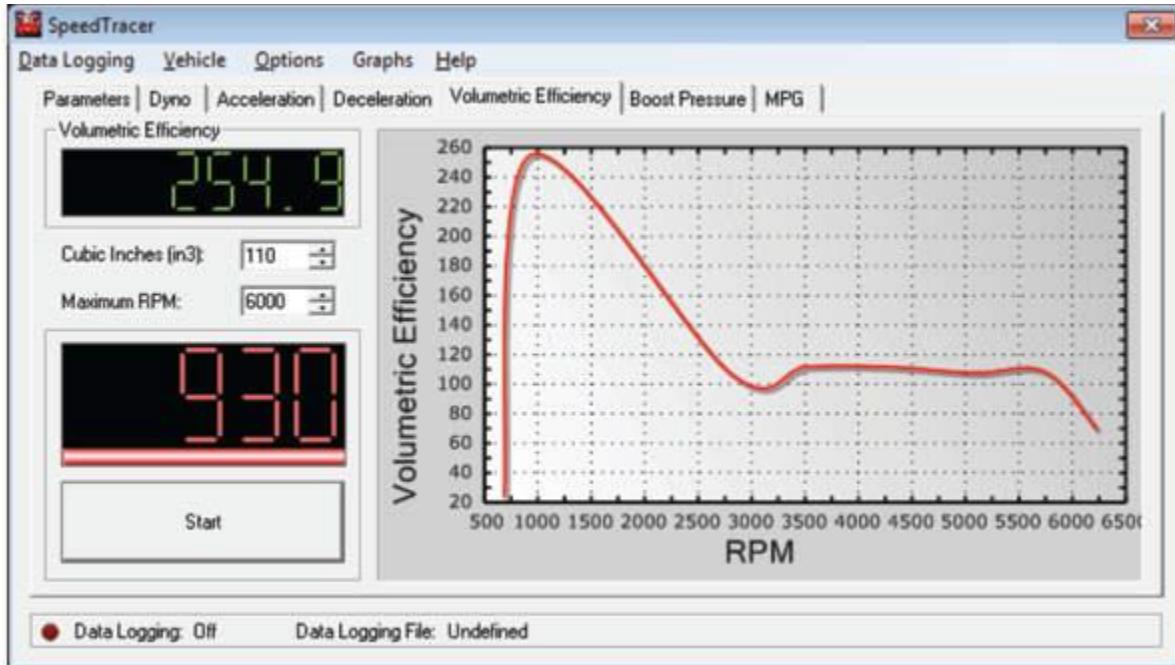
Fig. 6: Overreporting MAF on a Toyota Matrix.

We can see an overreporting MAF due to an incorrect replacement MAF sensor on a Toyota Matrix in Fig. 6.

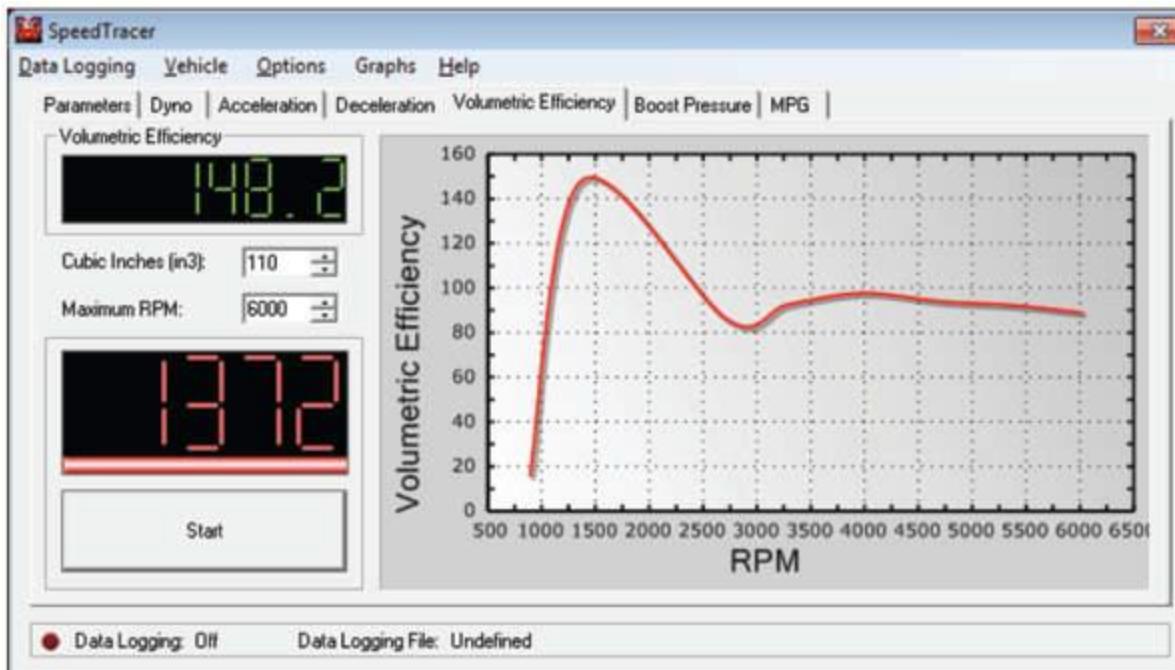
Fig. 7: Correct MAF signal on the same Toyota Matrix.

You can see in Fig. 7 that the correct MAF fixed the Matrix.

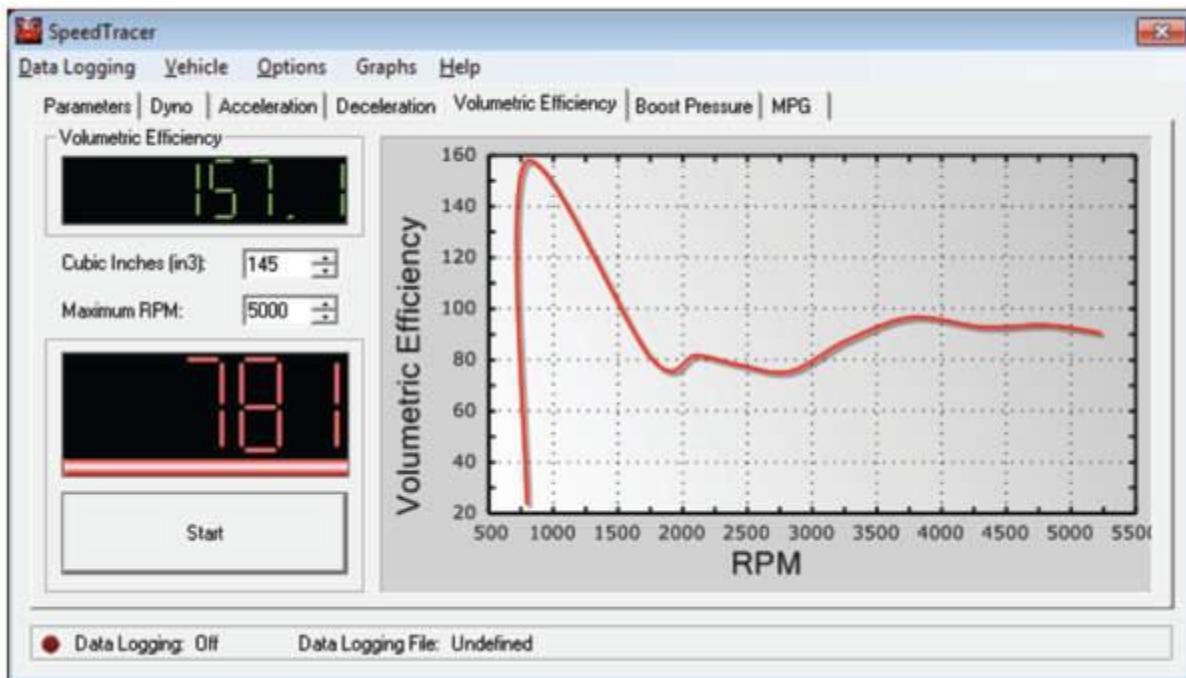
Fig. 8: Choked down air intake event.

You can see in Fig. 8 that we have a good MAF sensor, but something choked the airflow down. Remember the pen and paper method for VE? Would this restricted exhaust have been seen using that method?

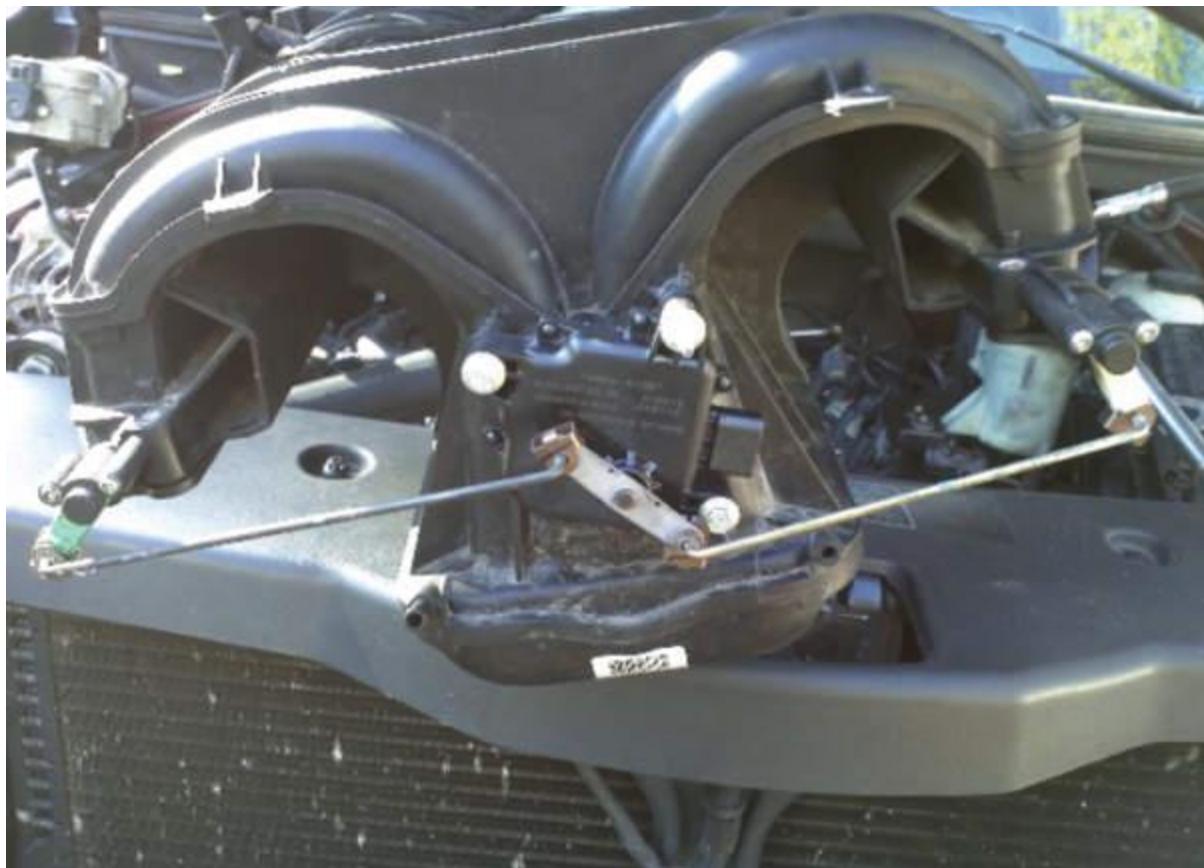
Fig. 9: Incorrect linkage setup.

Fig. 9 shows an incorrect Ford Intake Manifold Runner Control (IMRC) linkage setup.

The rods linking the IMRC shafts to the actuator have been reversed on this Ford F-150, so that they are physically closed when commanded open, and vise-versa. When it came time for the IMRC shafts to command open (at 2,500 rpm), they closed off in reality (Fig. 10).

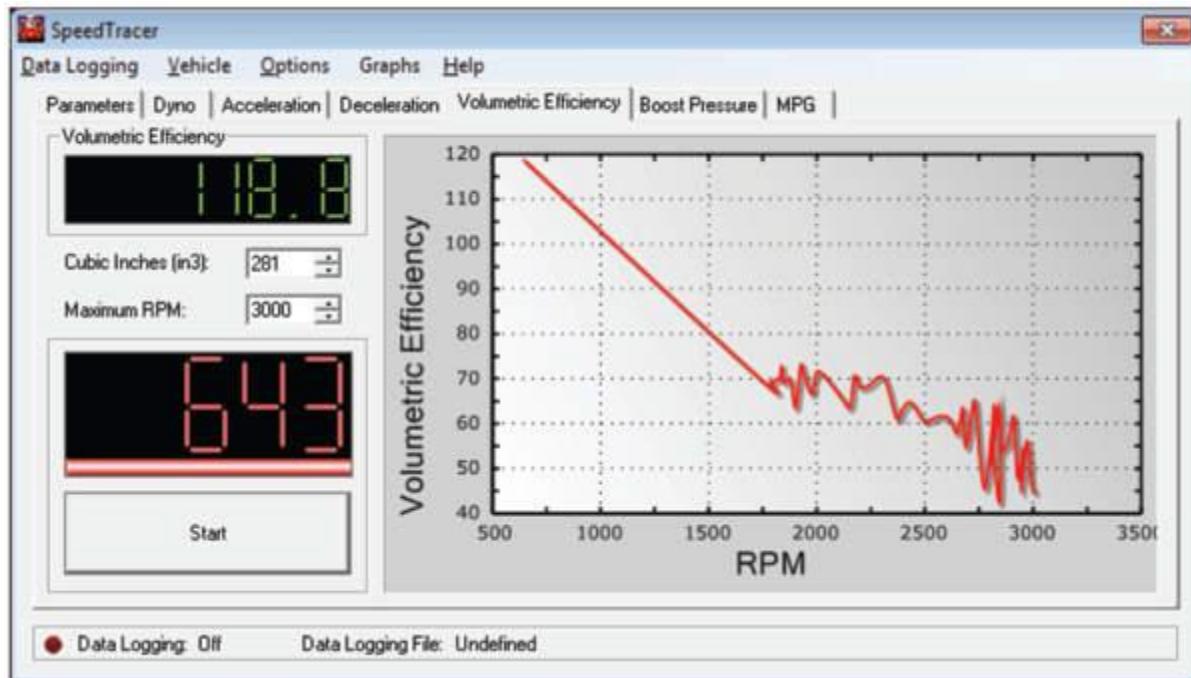
Fig. 10: Reversed linkage.

The only clue for this condition using conventional data was that the “feel” of the engine torque lowered when the IMRC changed state. But it is obvious here that something is wrong. We can see the difference in the post-repair capture (Fig. 12). See the correct IMRC rod orientation in Fig. 11.

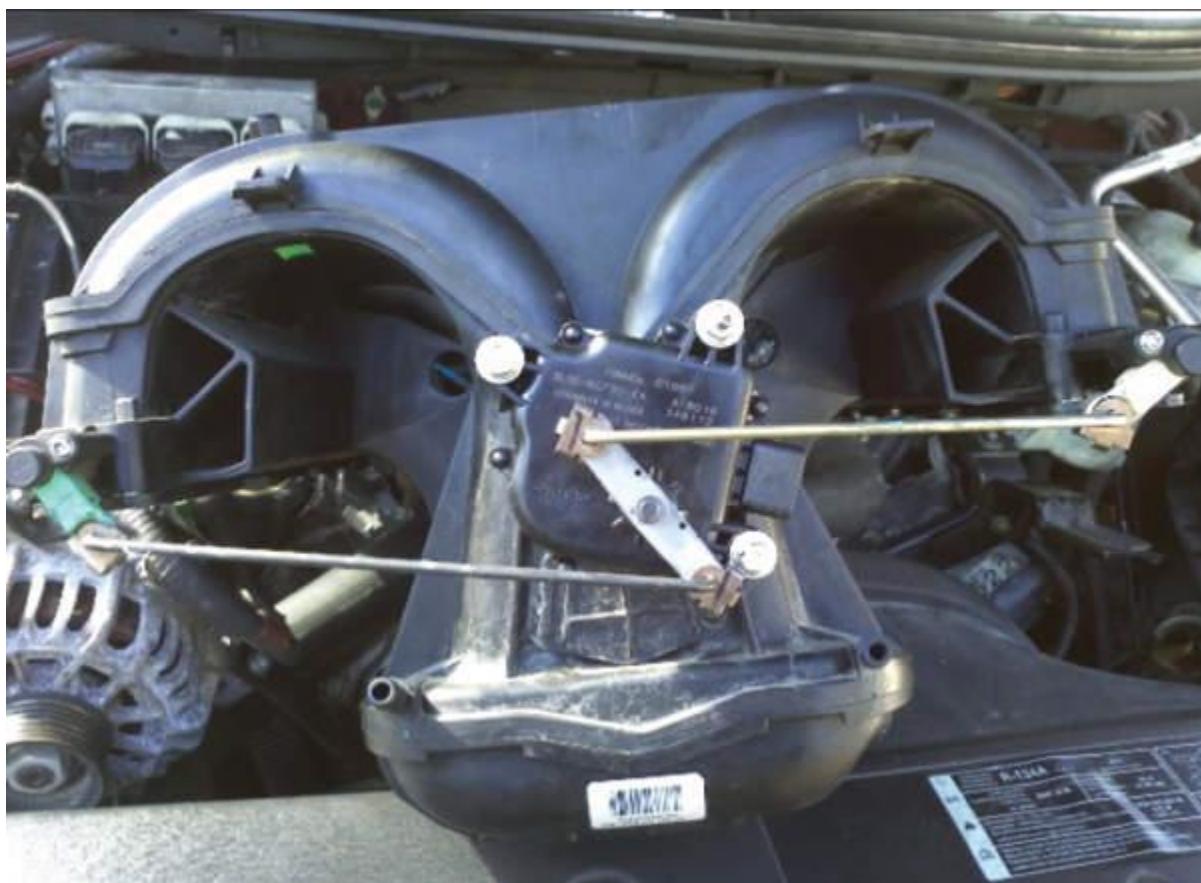
Fig. 11 Correct linkage setup.

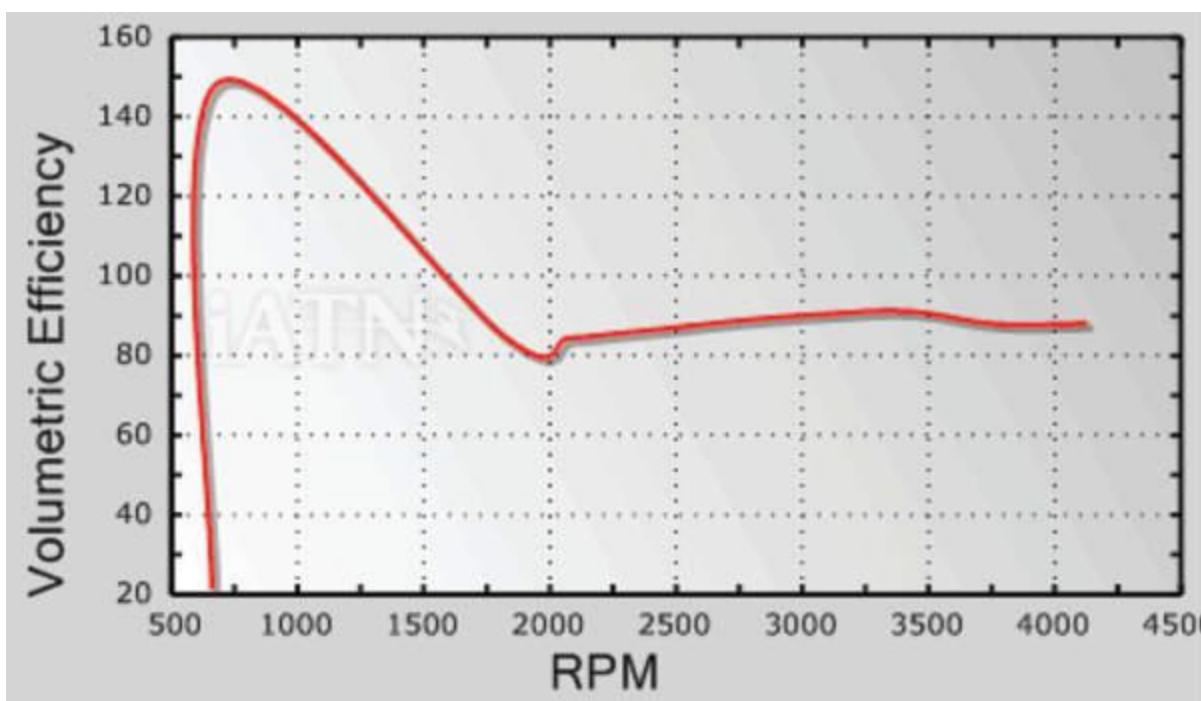
Fig. 12: Correct linkage

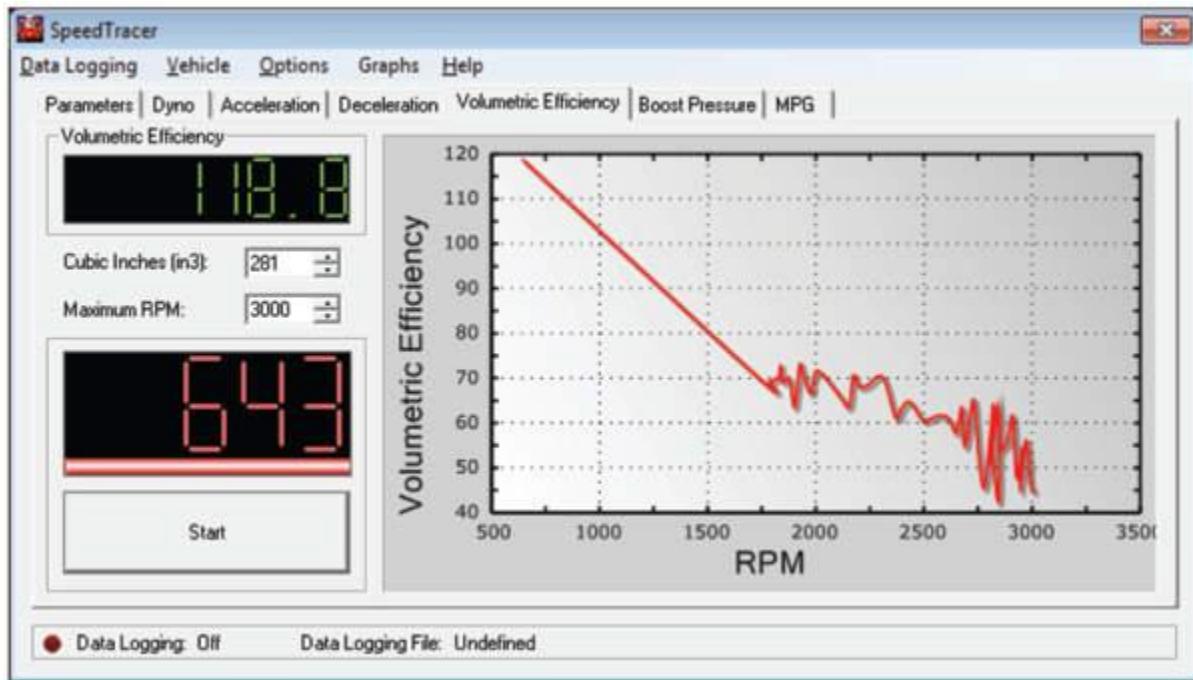
Fig. 13: Reversed linkage.

In Fig 13, we have a 4.2L with one CAT completely stopped up.

It would barely register over 3,000 rpms. There was absolutely no practical need for this, but I was curious.

Knowing that only three of the six cylinders can exhale, and that a huge part of the data comes from the MAF readings, what kind of image does that turbulence paint in your mind?

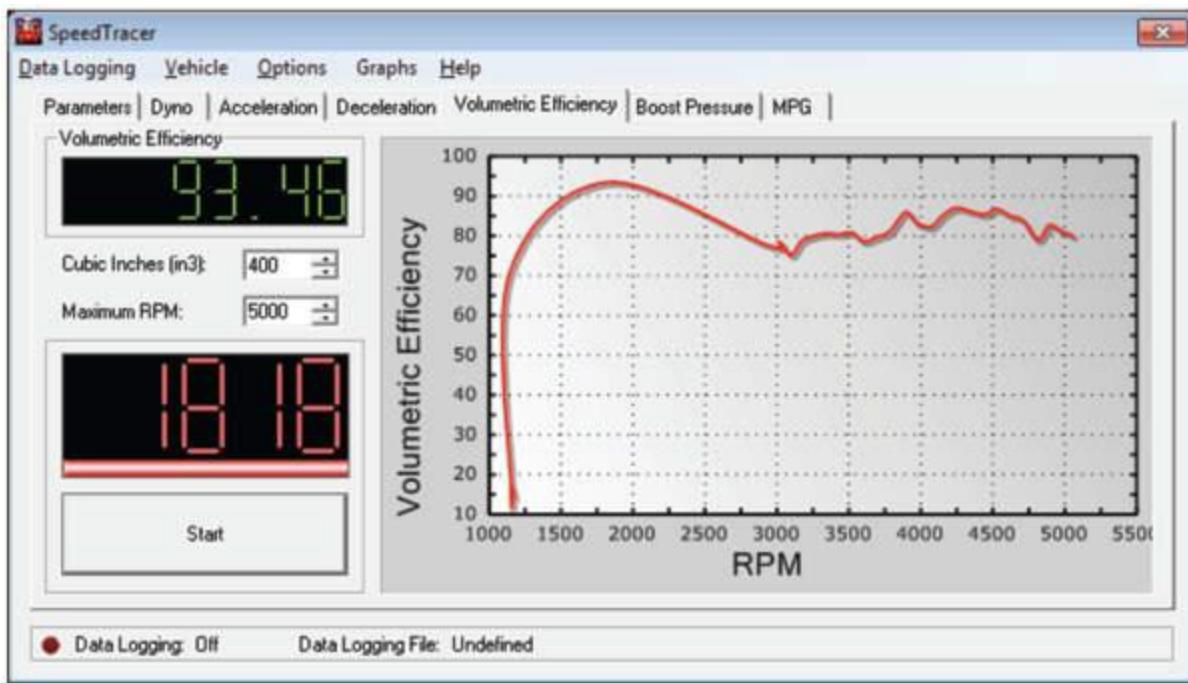
Fig. 14 shows a test subject that suffered catastrophic failure of both CATs. A series of samples were taken while chunks of material were blowing out of the tail pipe. This image repeated multiple times.

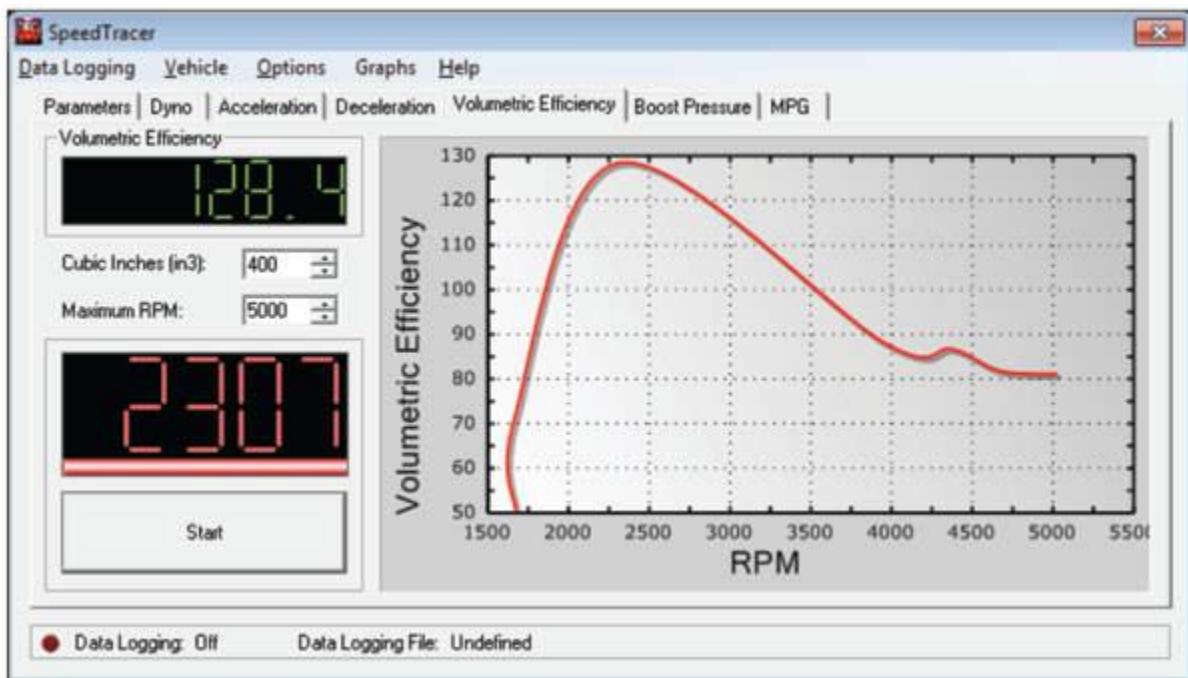
Fig. 15

Until it ran out of “bullets” (Fig. 15).
