Engine Polygraph Case History: Mercedes 15

CS-EP-03

Mercedes I5

Vehicle ID : 2006 Dodge Sprinter

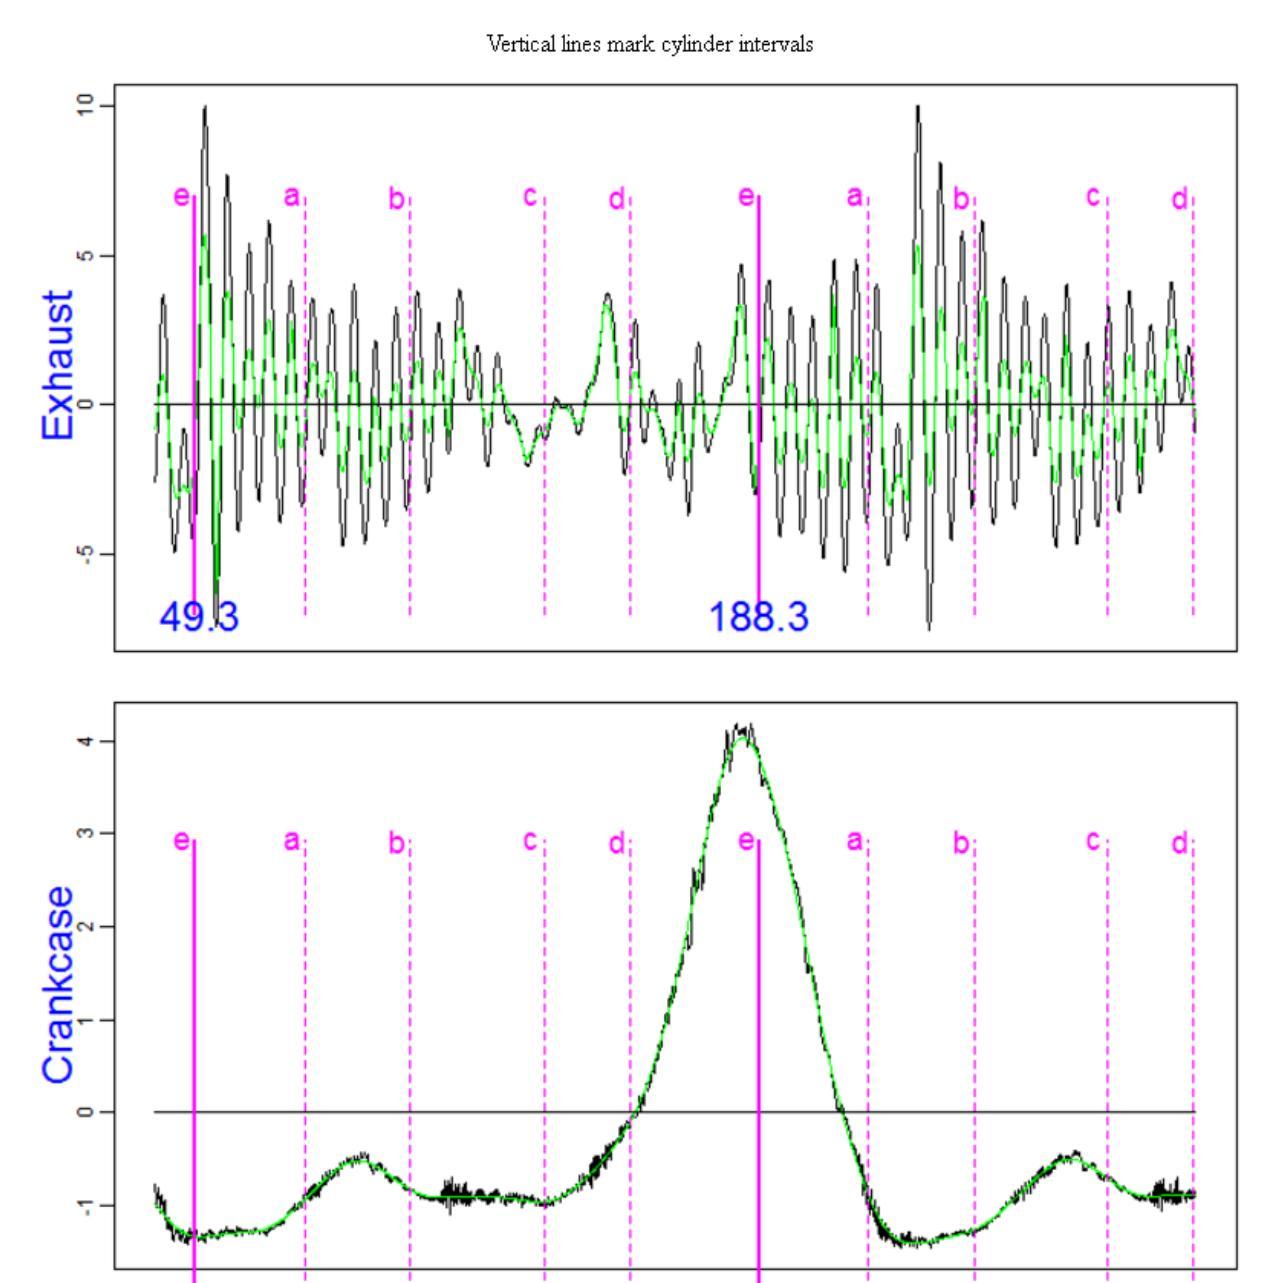
Polygraph Model

Waveform Analysis

The EP system did not get the rpm correct because a cylinder did not fire.

This pattern indicates that there is a regular mis-fire with fuel: the mis-fire is the Exhaust flat area at c. And it is followed by a large peak when the fuel that was not combusted hit the catalytic convertor and flashed.

When they took the engine apart, they found the problem - a hole burnt through the piston. Probably as result in detonations from premature ignition (compression stroke) before the hole burned through.
