Gasoline Direct Injection

Omar Trinidad

Southern Illinois University Carbondale, omar@siu.edu

This presentation covers some of the differences between GDI and FSI. More specifically, this article focuses on the issues facing the GDI systems.

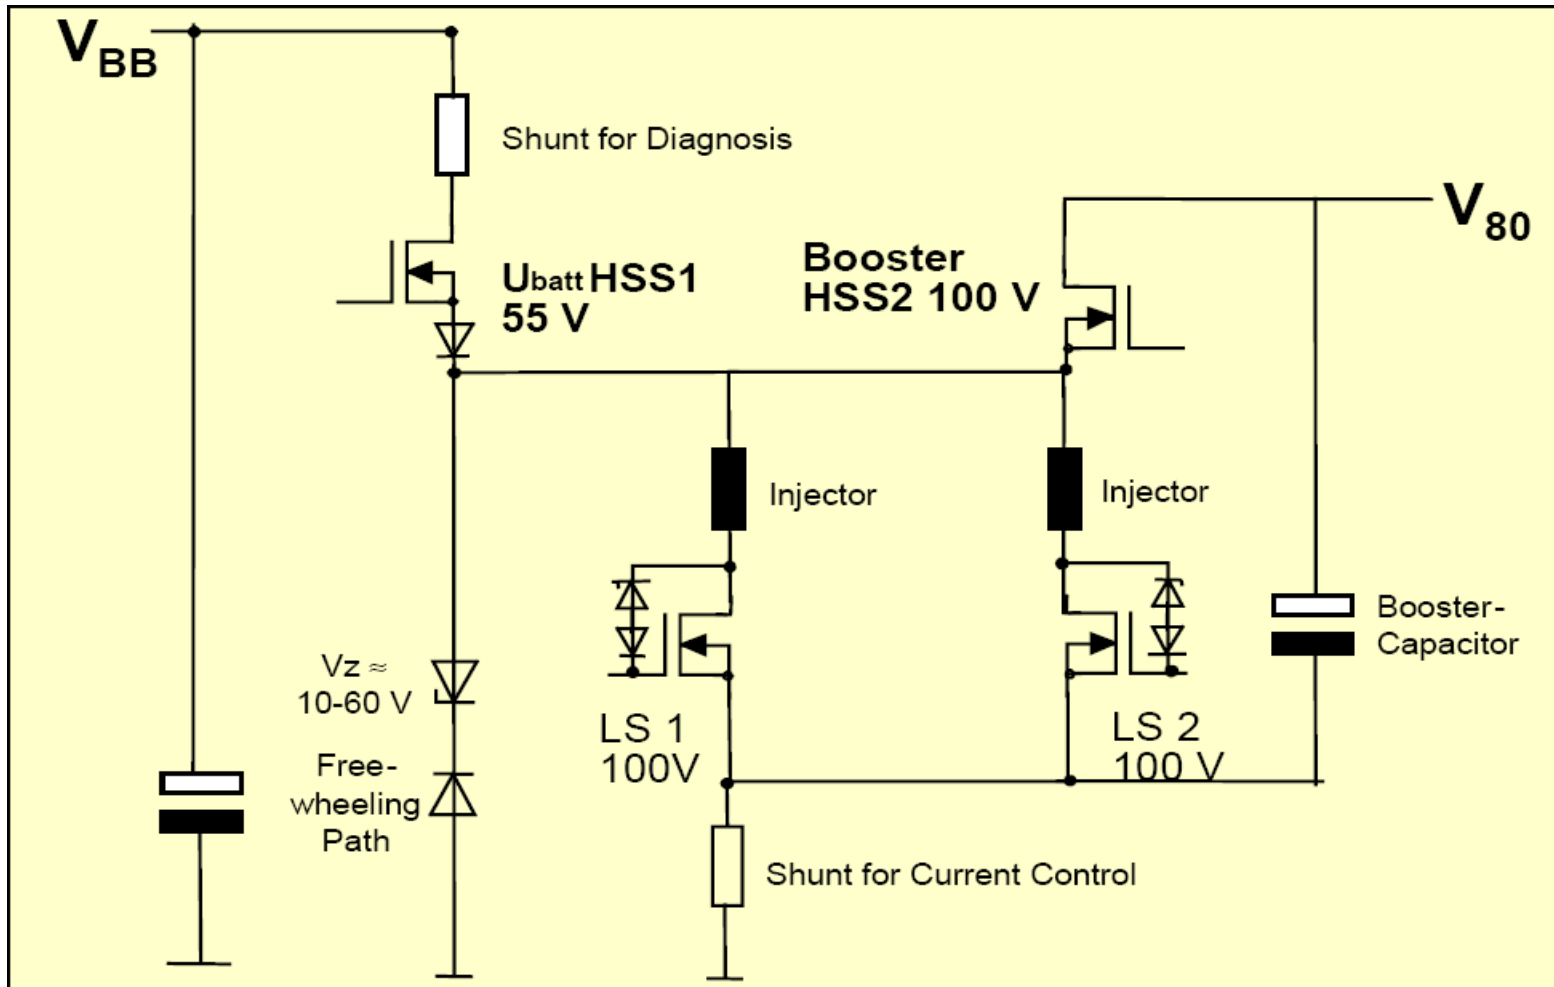
Controller Schematic

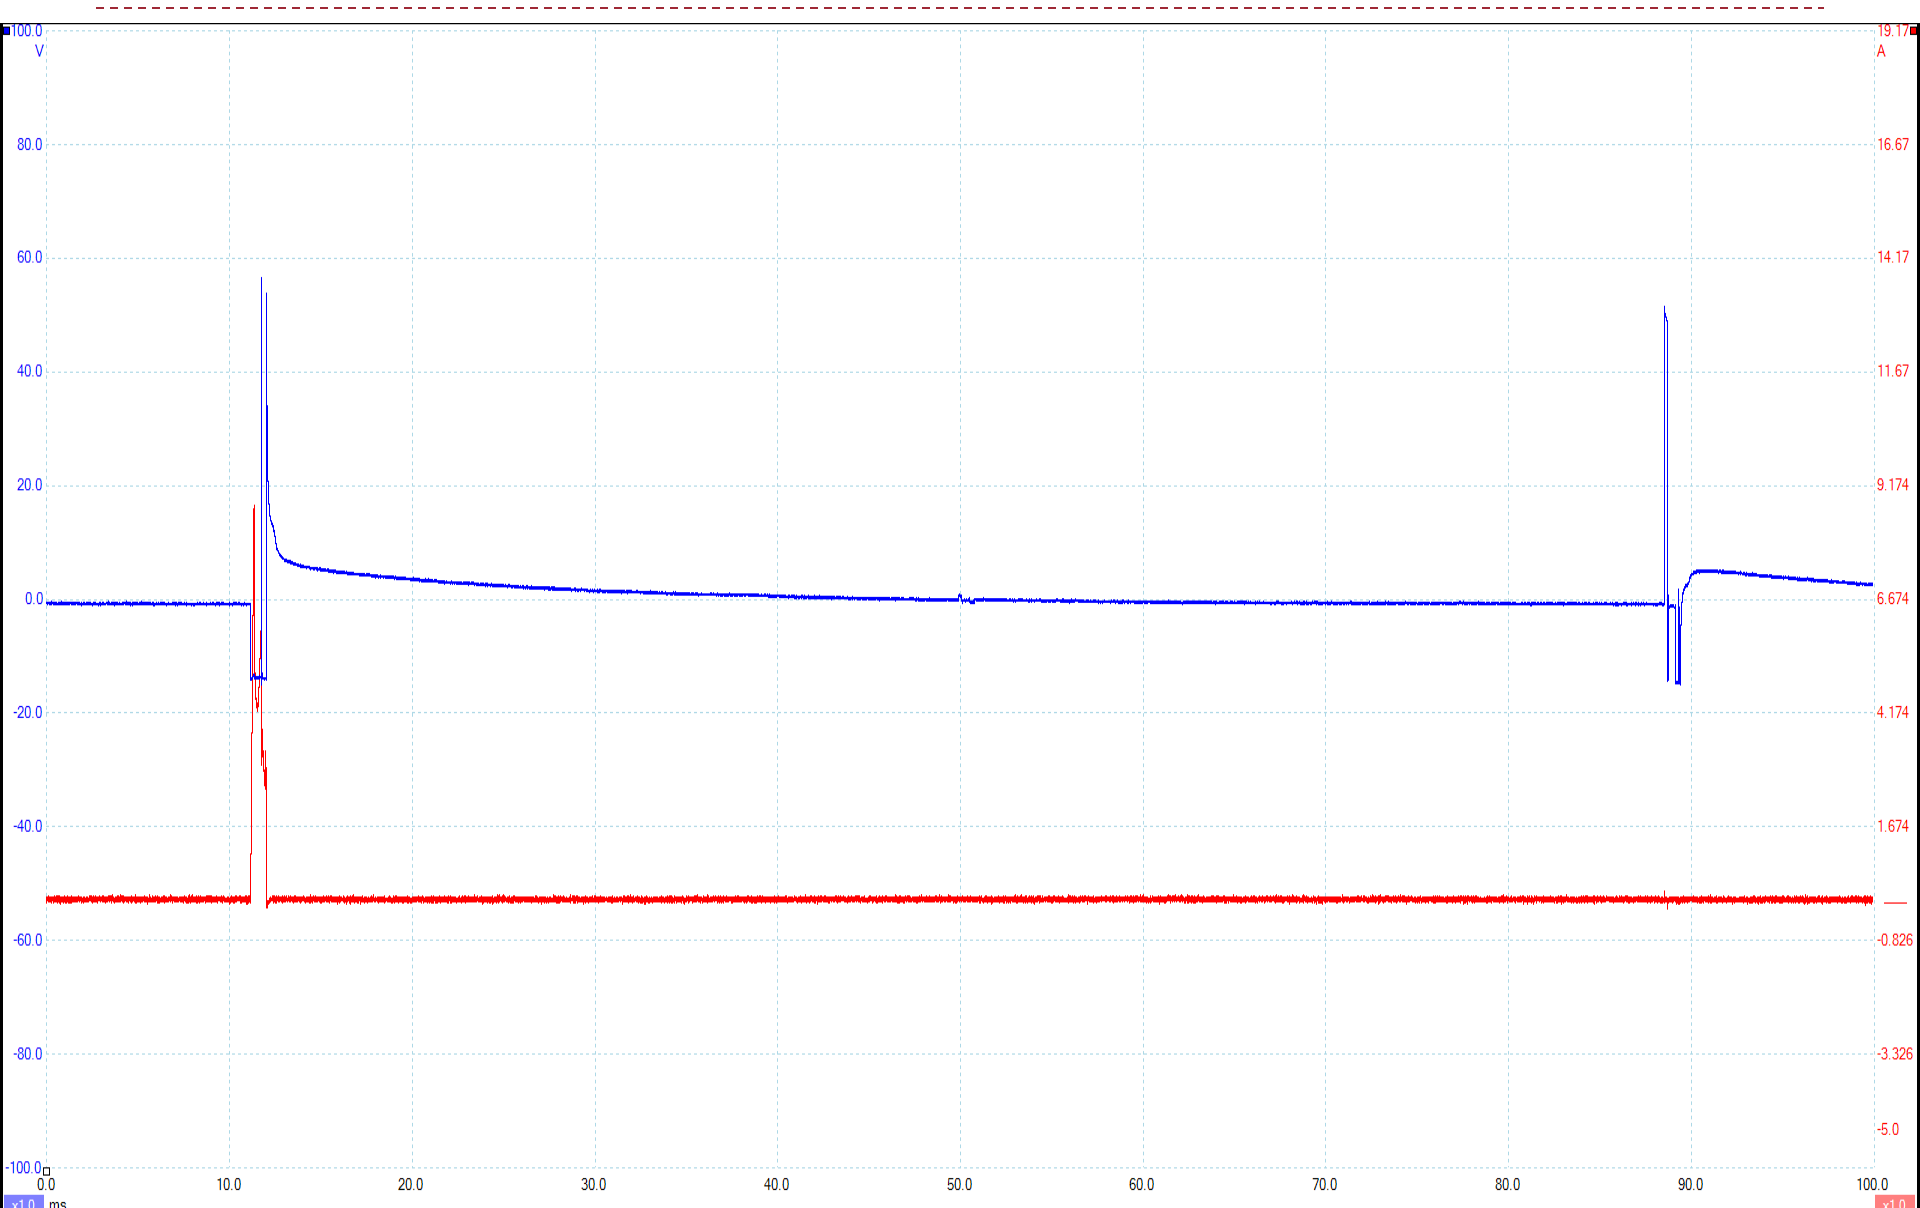
Paired Cylinders

- ▶ Voltage
 - ▶ Initial Pulse: 50-75 Volts
 - ▶ Duty cycled 12V
- ▶ Paired cylinders
- ▶ Power and Ground controlled
- ▶ Multiple Injection

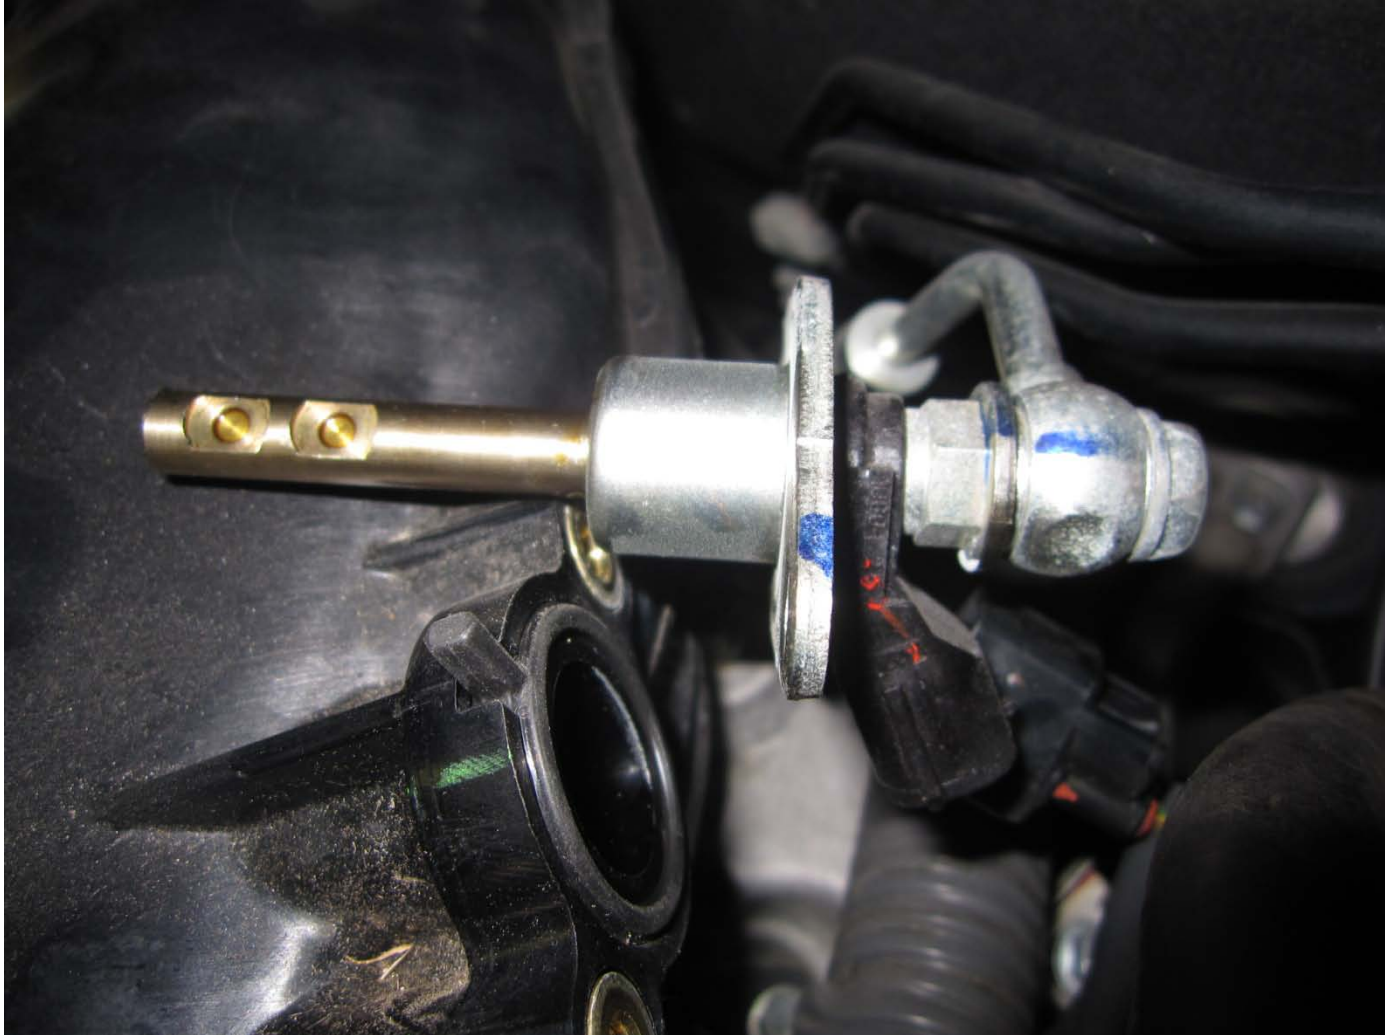
Cold Start Injector

- ▶ IS250 (2005-Present)
 - ▶ Direct injectors
 - ▶ Cold Start Injector

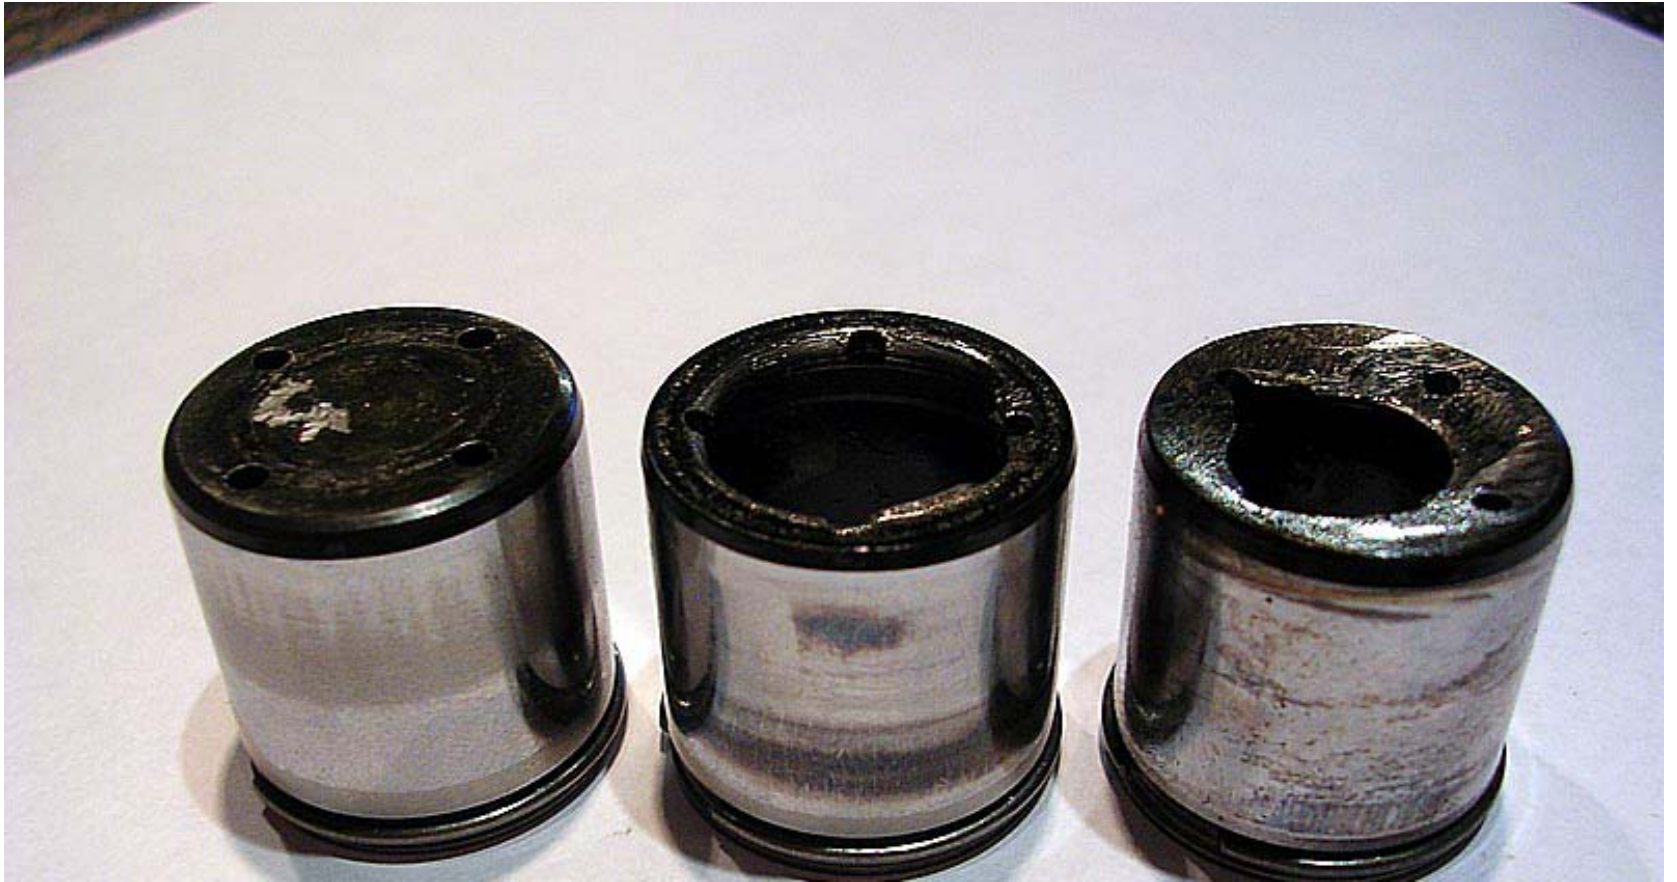
FSI Cam Follower

9K

111K

31K

Excessive wear of intake camshaft lobe that drives the high pressure fuel pump. The wear limits maximum pump piston lift, causing fuel rail pressure fluctuations.

The wear on the camshaft lobe can also lead to wear on the base of the high pressure fuel pump cam follower.

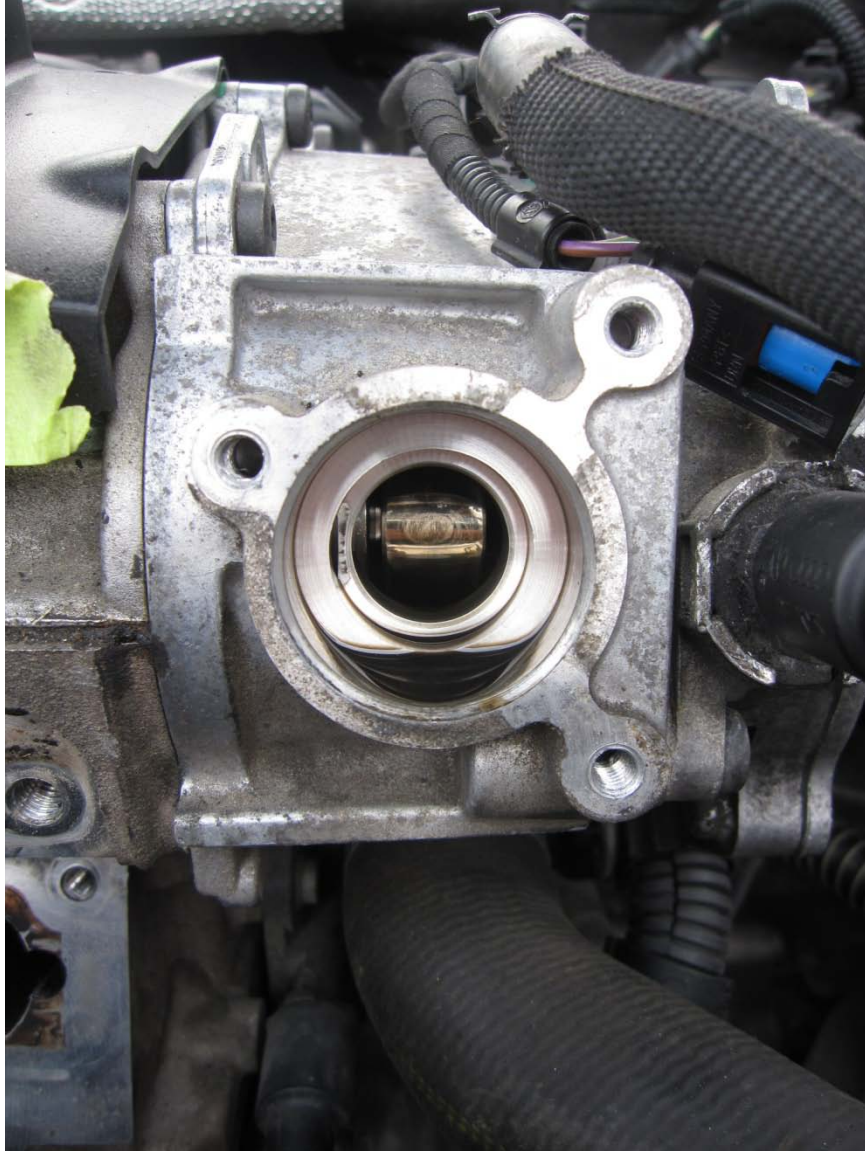
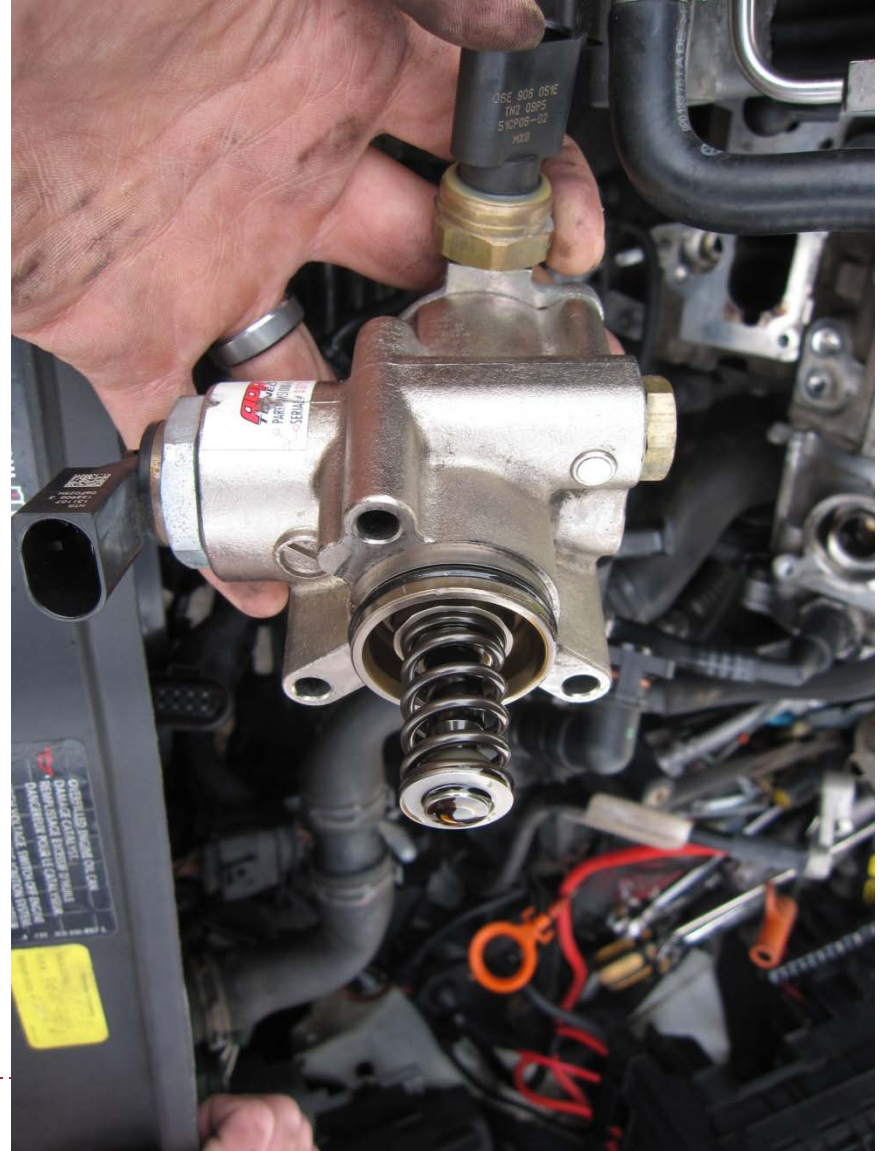
Cam Lobe

Increase surface hardening of camshaft lobe for the high pressure fuel pump. Improved intake camshafts have Part No. 06F109101B.

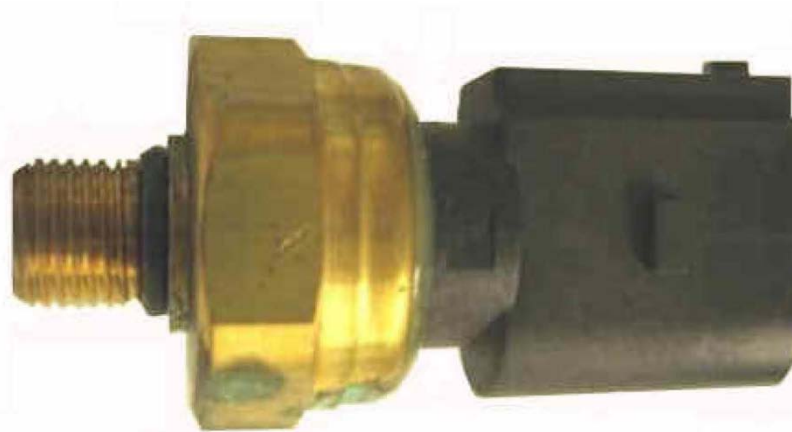
Fuel Pressure Sensor TSB

- ▶ June 7, 2010
- ▶ #2016182 Supersedes T.B. Group 01 number 07-69 dated Dec.13, 2007 due to updated thrust sensor part number for the 2.0L T (BPY) engine.
- ▶ MIL ON, DTC P129F and or P310B Stored in ECM Fault Memory
- ▶ Due to fuel intrusion into the Low Pressure Side Fuel Pressure Sensor -G410-, a false signal may be sent to the ECM resulting in a reading that is out of tolerance. A false signal may result in illumination of the malfunction indicator lamp (MIL) and DTC P129F or DTC P310B being stored in fault memory.
- ▶ Improved fuel pressure sensor -G410- to aid against fuel intrusion

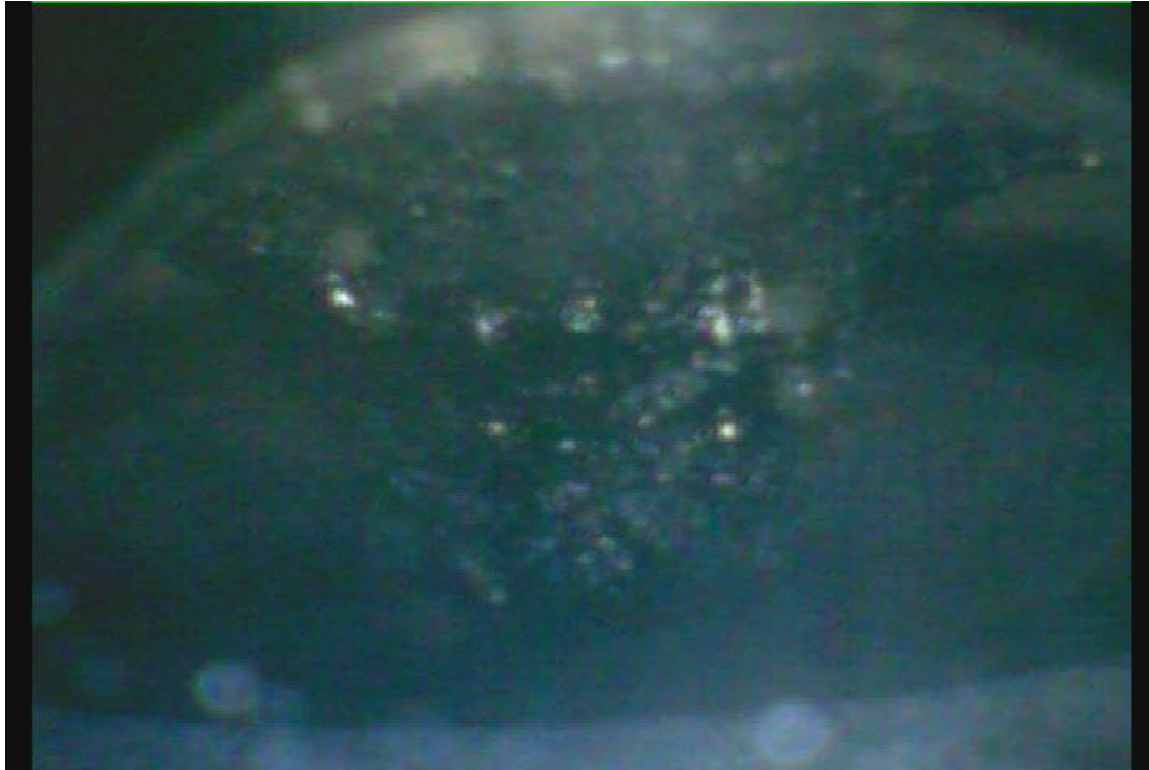
2006 Lexus IS250

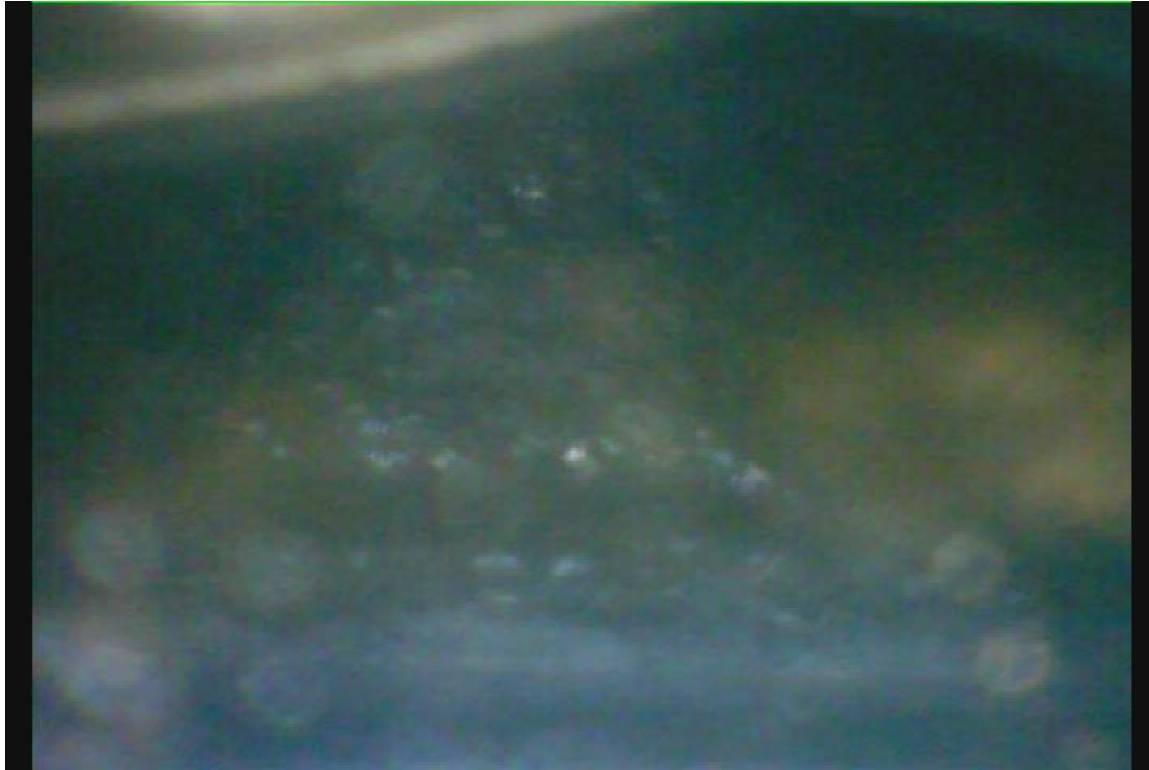
2006 Lexus IS250 After Cleaning
